01-20-03TT - MIL ON, NOx Sensor Circuit Range/Performance Fault P2201

6/19/2020

| Applicable Vehicles | | | | | | |
|---|---|---|---|---|---|--|
| Passat | 2012-2014 | 2.0L TDI (CKRA) | All | All | All | |

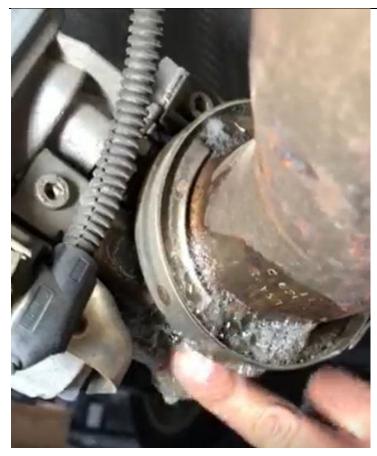
- 2.) If the "AF" index sensor is already installed on the vehicle, do not replace sensor on the first repair visit. Verify there are no leaks in the exhaust system upstream of the NOx Sensor, which may be contributing to erroneous sensor values. The VAS1687 tool is useful in pressurizing the exhaust, and a soapy water mixture works well to find leak areas. Pay close attention to the exhaust pipe connections on the exhaust flap for the low pressure EGR system. If leaks are identified, repair them as necessary. If the exhaust is verified to be leak free and an "AF" sensor variant is installed, replace the sensor if directed by GFF.

Figure 1. Example of exhaust leak at exhaust flap.
