Technical Service Bulletin

96 High beam assist or traffic sign detection limited, DTC C12B3FD stored in the driver assist systems control module

96 20 53 2059201/3 June 17, 2020. Supersedes Technical Service Bulletin Group 96 number 20-51 dated April 23, 2020 for reasons listed below.

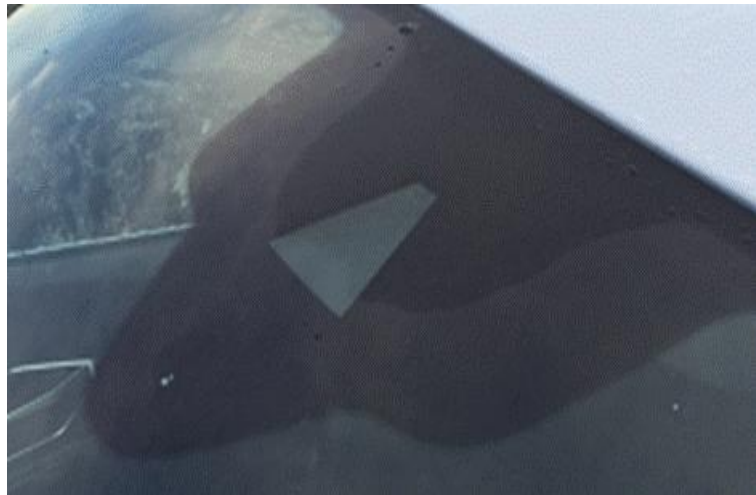
The viewing area of the front camera can be fogged up both on the inside and/or on the outside (Figure 1 and 2).

Figure 1. Viewing area fogged up from outside.

3. The customer cannot see this from the interior of the vehicle. Often it is enough to switch on the wiper system to fix the concern.
4. If the front camera is fogged up from the inside fairly often, it can help to remove its lens hood then to clean and dry the viewing area of the camera.

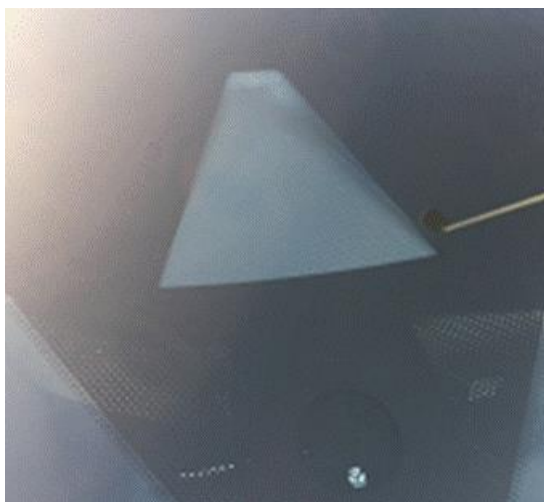
Figure 2. Viewing area fogged up from inside.
