Service Action

Code: 91Y3

Subject	MMI Software – System Privacy Mode																		
Release Date	June 18, 2020																		
Affected Vehicles

Subject: Service Action 91Y3 - MMI Software – System Privacy Mode

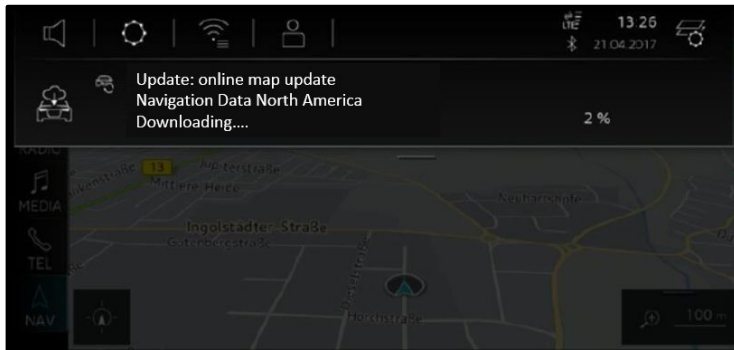
If the infotainment system happens to be in a navigation data download mode (“Downloading...,” as shown), please interrupt this by activating the slider for privacy mode (Home > Settings > Privacy settings > Activate privacy).

Please ensure that you deactivate privacy mode again after the software update is complete.

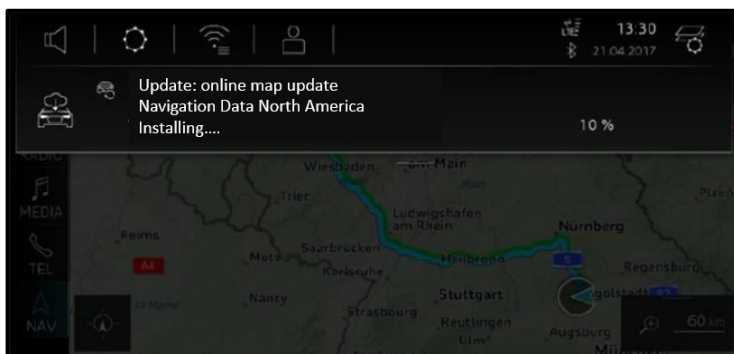
If the navigation database update is already being installed (“Installing...,” as shown), please wait and ensure that the installation is fully complete before continuing with the 91Y3 software update.

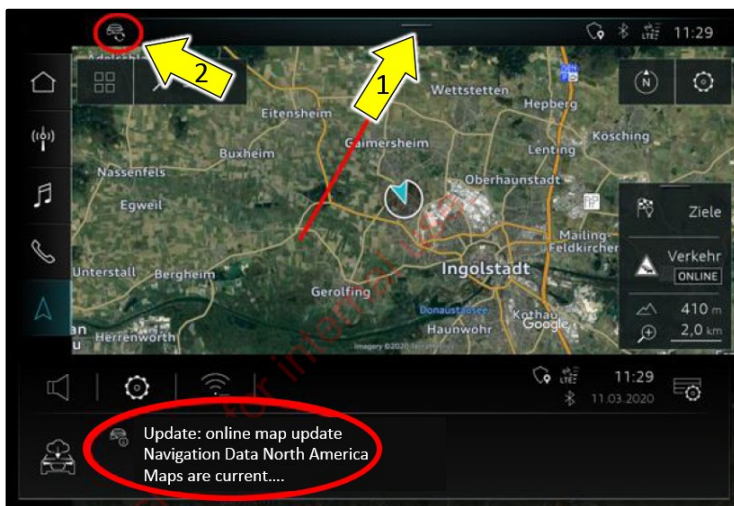
If a navigation database update is already complete, it is very important to confirm this manually in the notifications center of the MMI.

To do so, pull the notification center downwards <arrow 1> and confirm the completion (“Maps are current...,” as shown).

The 91Y3 software update can only be started when the icon at the top left <arrow 2> is no longer visible.

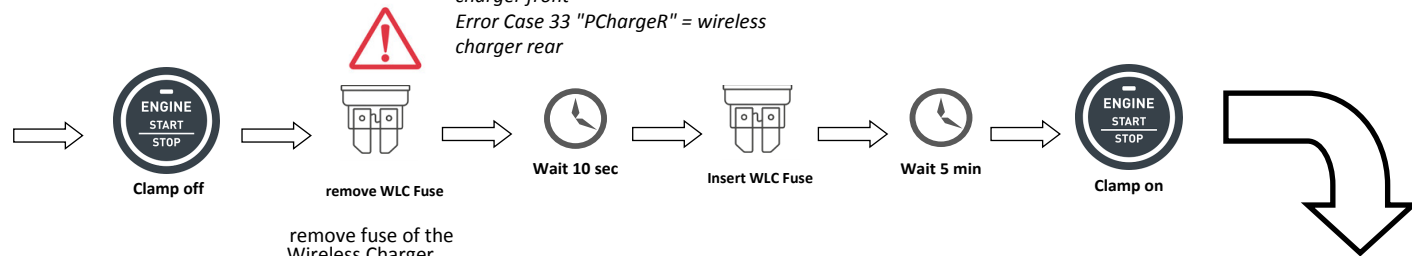
Error 33: PChargeF or PChargeR

Error Case 33 "PChargeF" = wireless charger front
 Error Case 33 "PChargeR" = wireless charger rear

remove fuse of the Wireless Charger "recharger 1 for mobile end device" ---

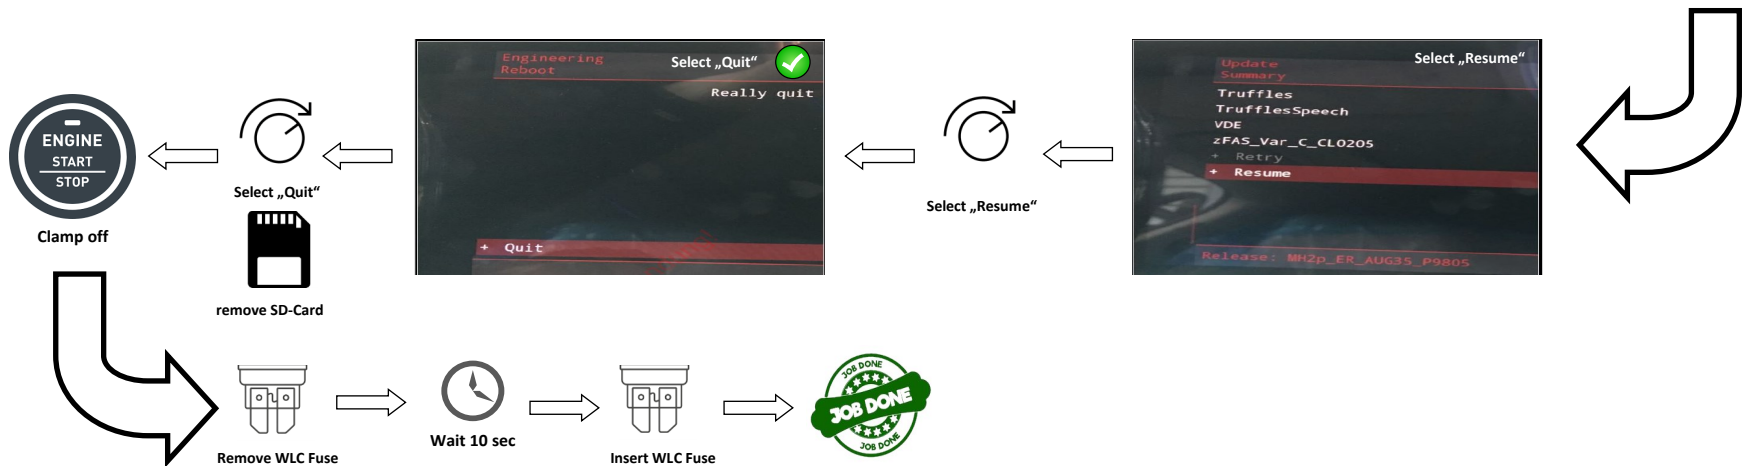
Error 128: zFAS_Var_C_CL0205...

Note: This step is only necessary if Error 128 on Block 41 occurs!

remove fuse of the Wireless Charger "recharger 1 for mobile end device" ---

In case of the A8 it is also necessary to remove the rear Wireless Charger fuse "recharger 2 for mobile end device". The fuse is located at the rear left trunk position --> Repair Instruction --> circuit diagram --> fuse point of installation
