24-18-01 - MIL ON, DTCs P2004, P2014 and or P2015 Stored in ECM Fault Memory

Release date: 6/15/2020

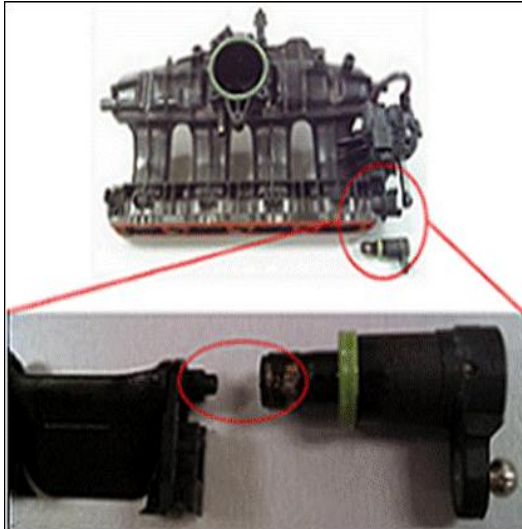
**Intake Manifold flap (BPY/CCTA/CBFA).**

The intake manifold flap can separate internally and will not operate correctly with the regulator valve. See Figure 1. and Figure 2. for an example of a damaged flap disassembled.

Check intake manifold flaps and if necessary replace intake manifold.

If the carrier plate can be pulled out, the flap has separated and the intake manifold must be replaced. See Repair Group 24 Multiport Fuel Injection in Elsa.

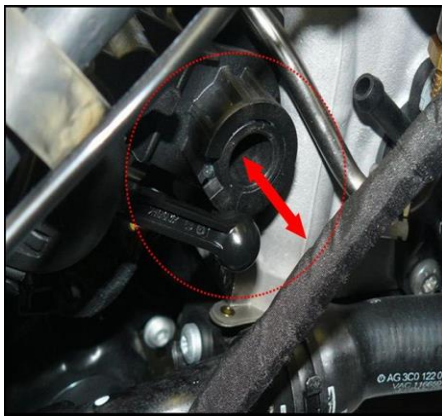
**Figure 3.**

- Remove the engine cover. See Repair Group 10 Engine Assembly in Elsa.
- Move the carrier plate by hand in an axial direction (Figure 3, red arrow) to check if the carrier plate can be pulled out.

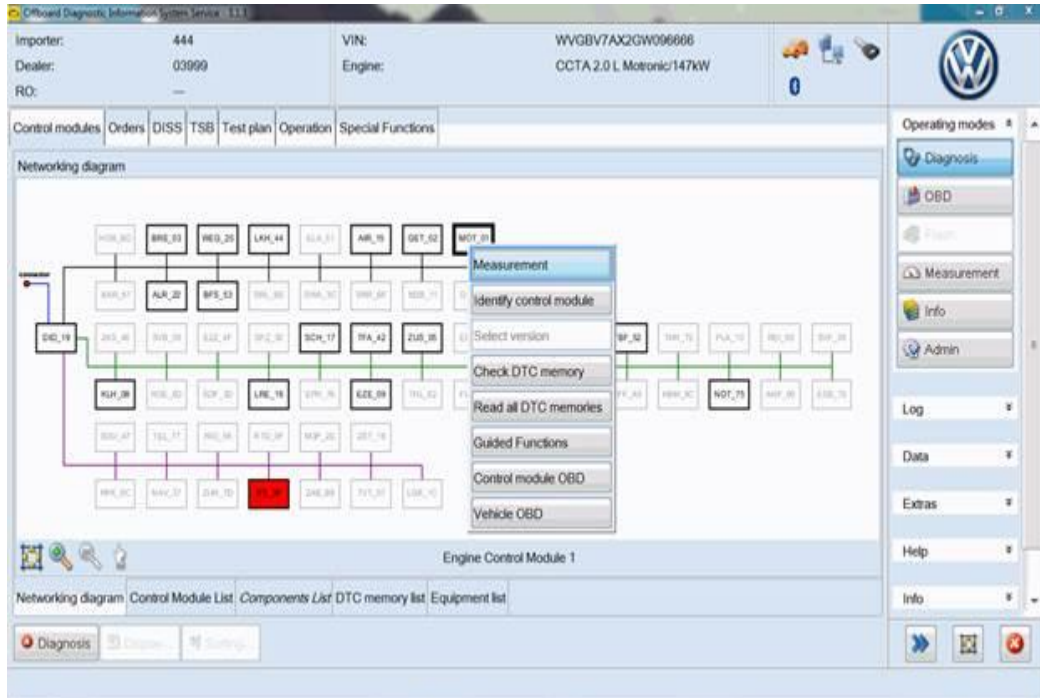
Figure 4

- Check the diagnostic limits of the flap with the ODIS tester.
- Under Motor, select Guided Functions (Figure 4).

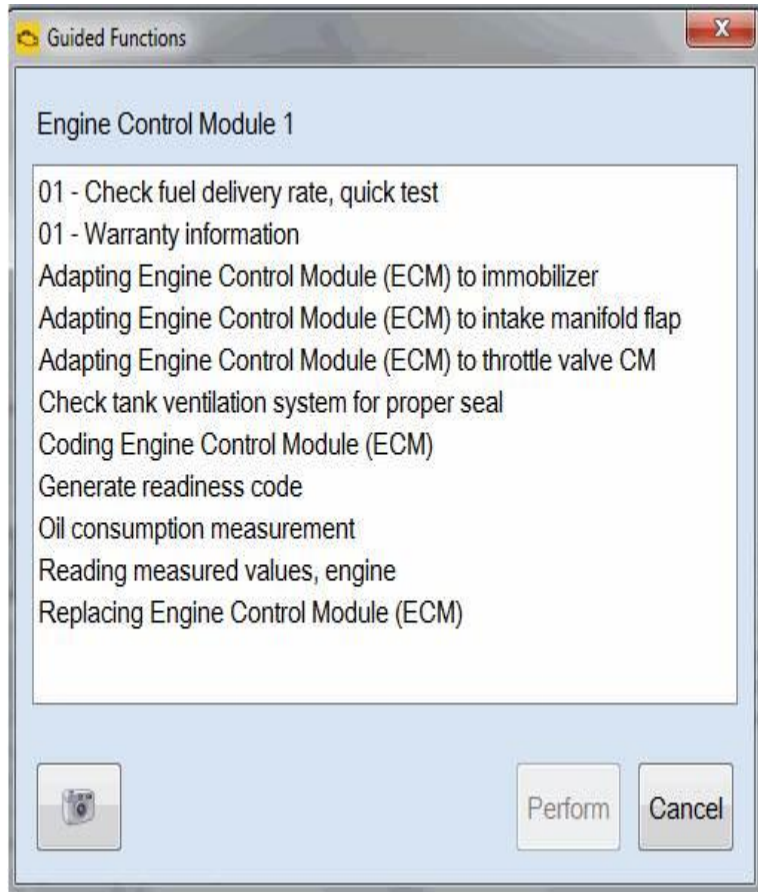
Figure 5

- Select Adapting Engine Control Module (ECM) to intake manifold flap (Figure 5).

If the adaptation is not successful, the flap stop is worn internally, the intake manifold also has to be replaced. See Repair Group 24 Multiport Fuel Injection in Elsa.
