June 19, 2020

Version 1

Squeaking or Creaking from Front of Vehicle Going over Bumps

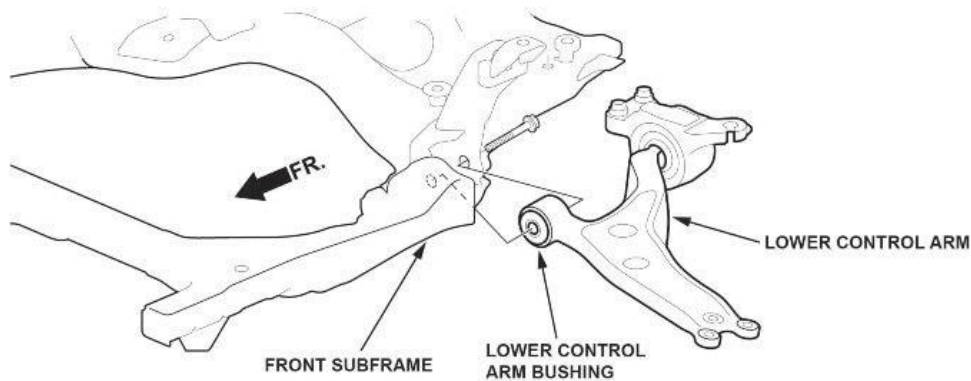
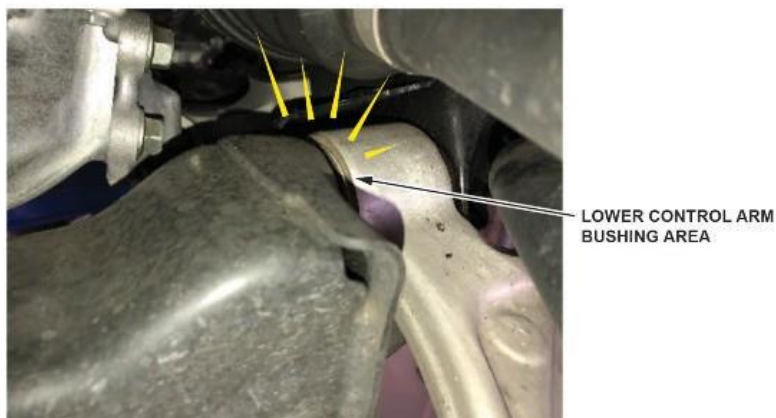
The rubber in the right or left lower control arm bushing is contacting the front subframe.

Using a ChassisEar, make sure the noise is coming from the lower control arm bushing. Isolate the noise to either the left, right, or both control arms, then replace the affected parts.

Replace the lower control arm.
