# TECHNICAL SERVICE BULLETIN

Technical Service Bulletin: 225-1190

# SERVICE BULLETIN 2020-06-17

**Subject:** Lead rail Connector Locking Washer Replacement

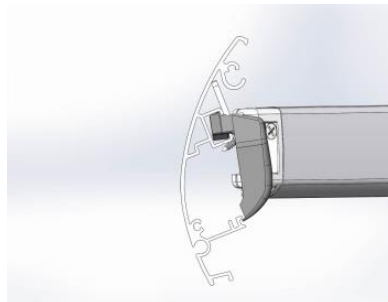
Screw location between lead rail and casting

- 5) Install washer locking screw in the Lead rail locking washer slot, located directly below the bolt. It may be necessary to press up on the canopy slightly to obtain the correct angle for driving the screw.
