GLOBAL SAFETY FIELD INVESTIGATIONS DCS5384 URGENT - DISTRIBUTE IMMEDIATELY

Subject: N202297690 - Service Update

Transmission Mount Snubber Noise

Models: 2020 Cadillac CT5 equipped with all wheel drive (RPO F46)

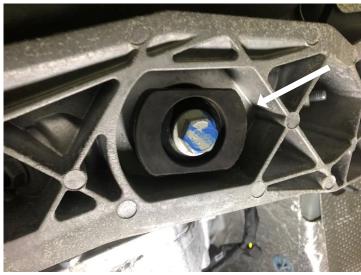
5595895

- 1. Raise and support the vehicle. Refer to Lifting and Jacking the Vehicle in SI.
- 2. Locate the transmission mount bolt and snubber:

2.1. If the transmission mount snubber is in the correct location, no further action required.

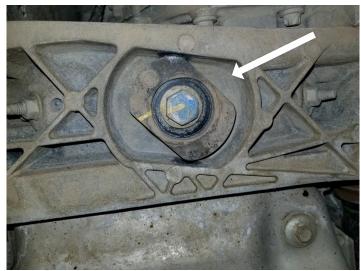
5595896

- 2.2. If the transmission mount snubber IS NOT in the correct location, continue to step 3.
- 3. Install a suitable jack stand, support the rear of the transmission.
- 4. Loosen the transmission mount bolt. Do not remove.
