Service Update

N192282860 Software Update for Internal Range Sensor Failure

Release Date: May 2020

Condition	Certain 2020 model year Cadillac CT4, Chevrolet Express, Silverado, GMC Savana and Sierra vehicles may have a condition where the transmission enters a neutral state when the internal range sensor (IRS) fault is active.
Correction	Dealers are to reprogram the transmission control module.

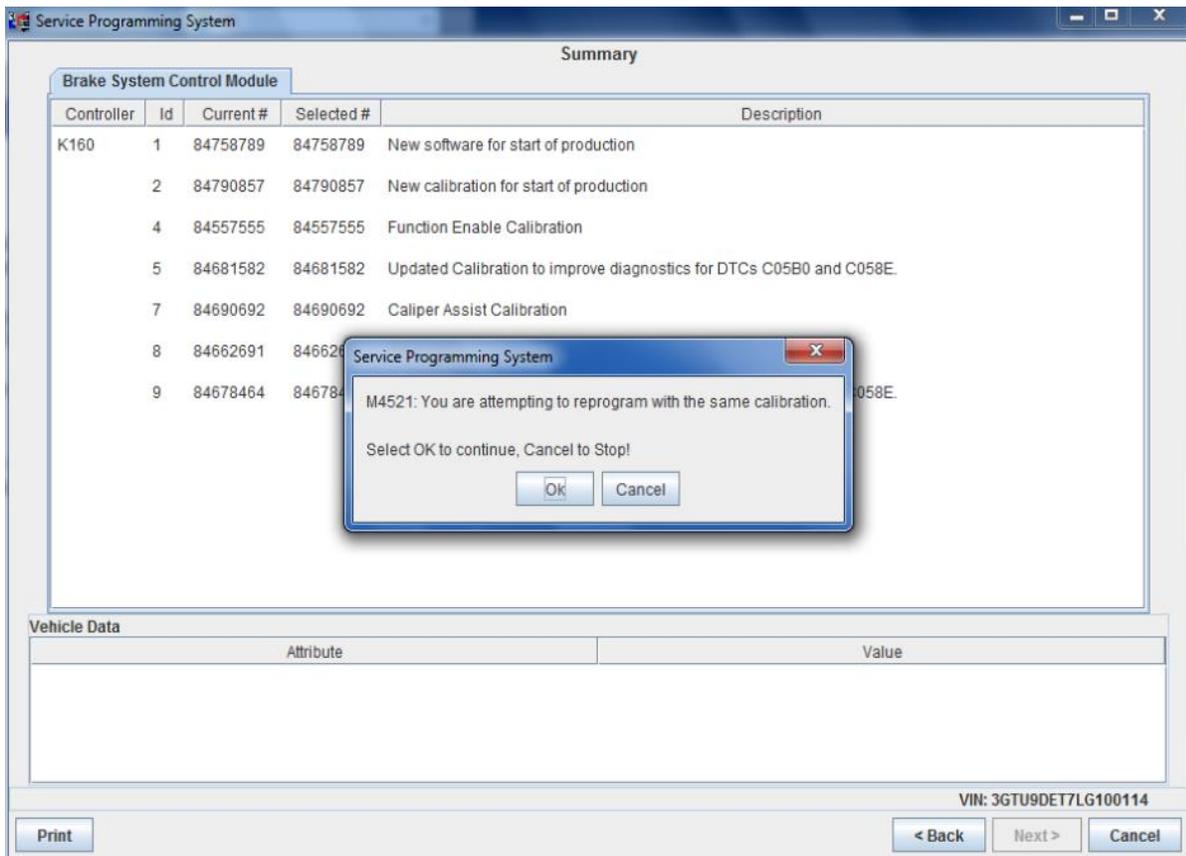
5431207

Important: TIS2WEB screen shown. Techline Connect screen is similar and will be included in the near future.

Important: If the Same Calibration/Software Warning is noted on the SPS screen, select OK and follow screen instructions. After a successful programming event, the WCC is located in the Service Programming System dialogue box of the SPS Summary screen. No further action is required. Refer to the Warranty section of the bulletin.

1. Reprogram the Transmission Control Module. Refer to *K71 Transmission Control Module: Programming and Setup* in SI.
 - Perform a shift adapt learn procedure. Refer to *Reset Transmission Adapts* in SI.

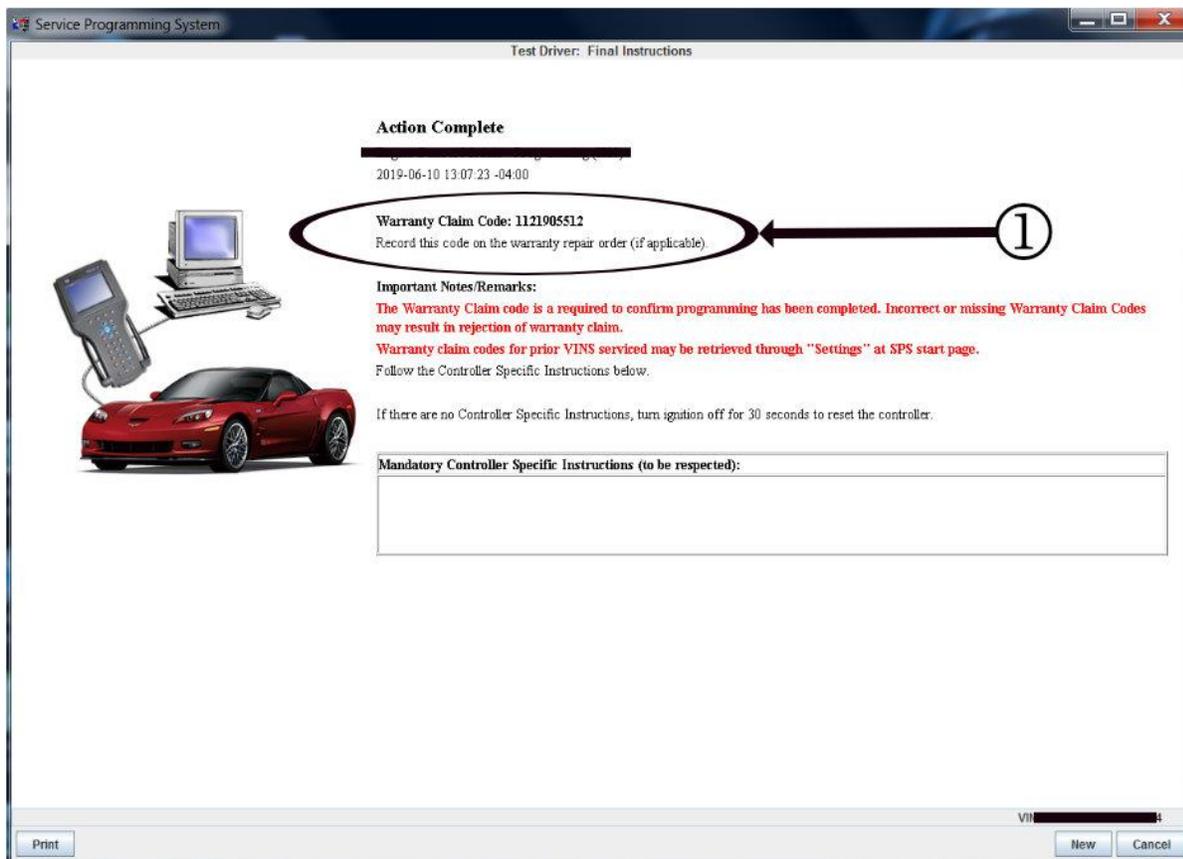
5431209

Important: TIS2WEB screen shown. Techline Connect screen is similar and will be included soon.

Important: To avoid warranty transaction rejections, you **MUST** record the warranty claim code provided on the SPS Warranty Claim Code (WCC) screen on the job card. Refer to callout 1 above for the location of the WCC on the SPS screen.

- Record SPS Warranty Claim Code on job card for warranty transaction submission.
