Service Update

A202301230 Reduced Launch Performance

Release Date: May 2020

Condition	Certain 2021 model year Chevrolet Trailblazer, and 2020-2021 model year Buick Encore GX vehicles, equipped with a continuously variable ratio (CVT) transmission, may experience reduced launch performance during a quick exit from a stop/start event. DTC's P0746 and P0776 may also set illuminating a Check Engine Light. The main pump in the CVT has a priming delay under certain conditions.
Correction	Dealers will reprogram the transmission control module (TCM) with updated software.

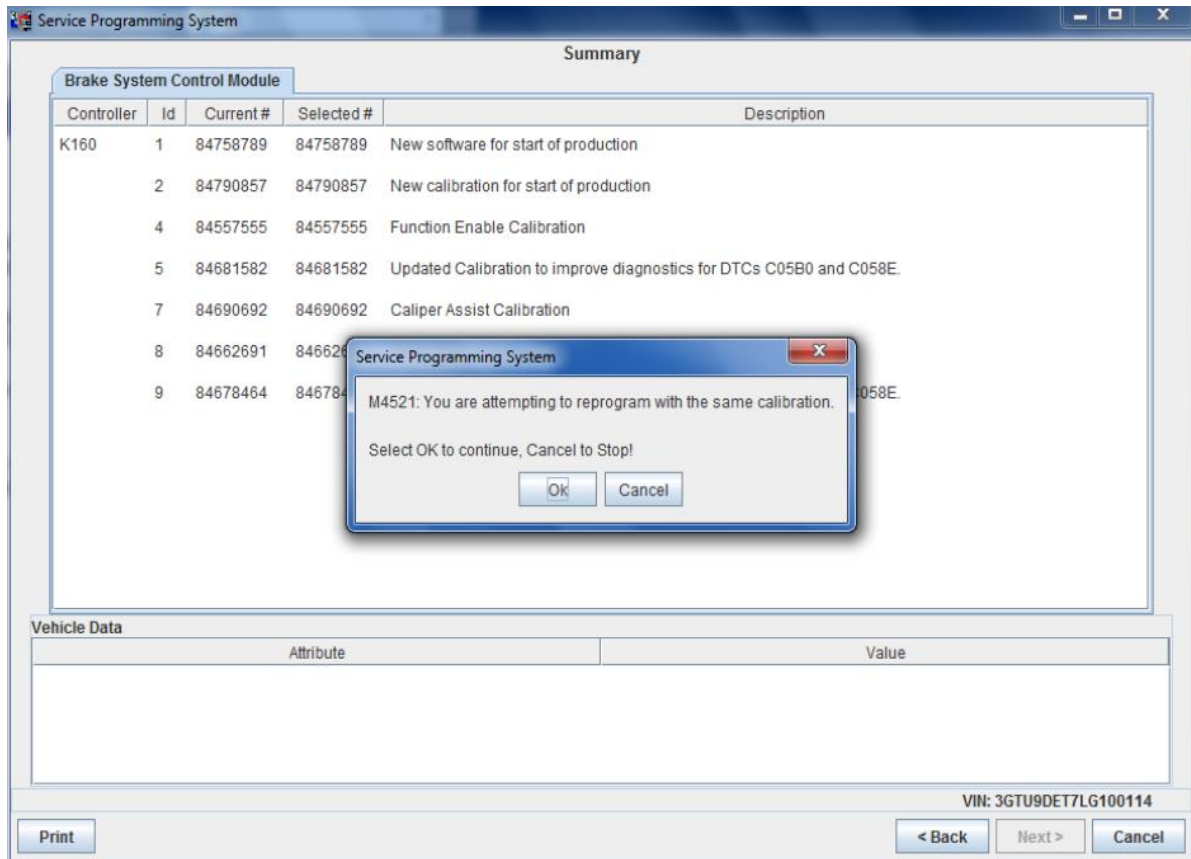
5431207

Important: If the Same Calibration/Software Warning is noted on the SPS screen, select OK and follow screen instructions. After a successful programming event, the WCC is located in the Service Programming System dialogue box of the SPS Summary screen. No further action is required. Refer to the Warranty section of the bulletin.

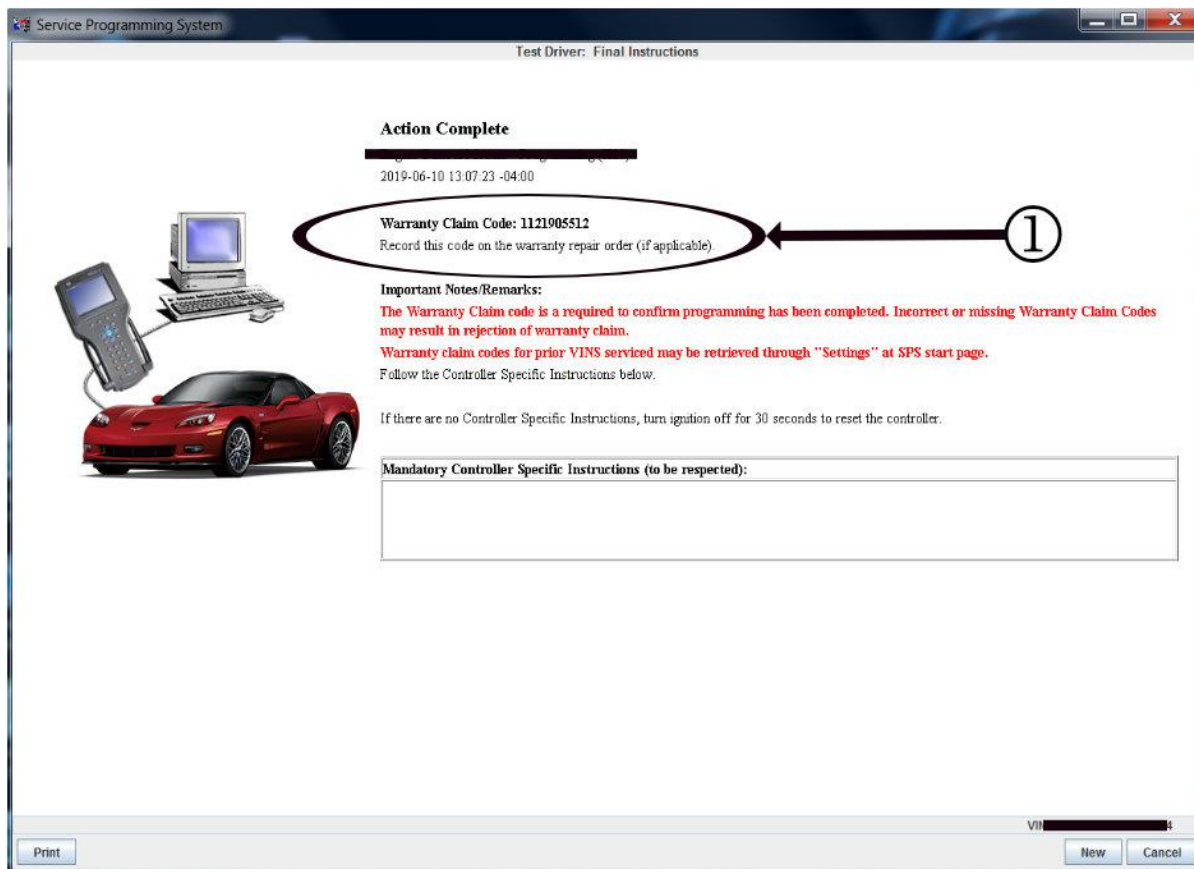
5431209

Important: To avoid warranty transaction rejections, you **MUST** record the warranty claim code provided on the SPS Warranty Claim Code (WCC) screen on the job card. Refer to callout 1 above for the location of the WCC on the SPS screen.

7. Record SPS Warranty Claim Code on job card for warranty transaction submission.
