# Customer Satisfaction Program

## N192272400 Rear Wheels Lock At Low Speed

Release Date: May 2020

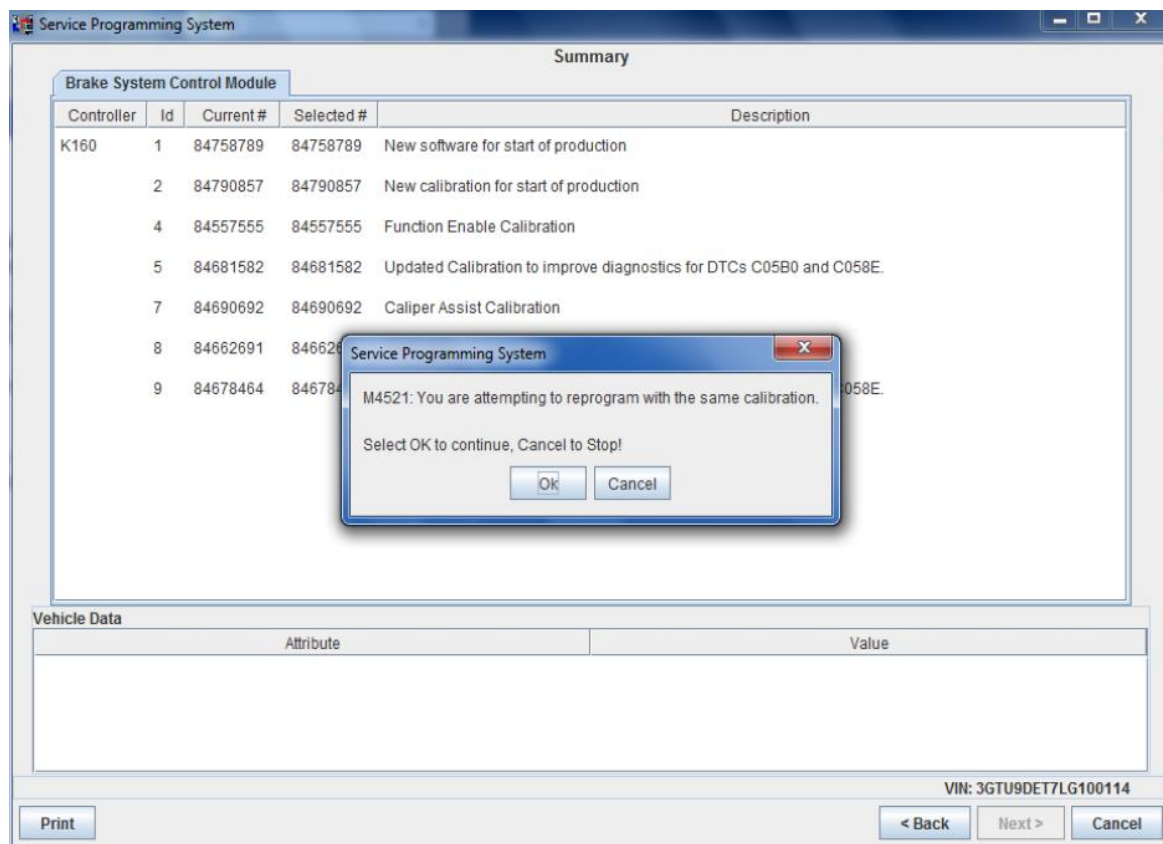
5431207

**Note:** If the Same Calibration/Software Warning is noted on the SPS screen, select OK and follow screen instructions. After a successful programming event, the WCC is located in the Service Programming System dialogue box of the SPS Summary screen. No further action is required. Refer to the Warranty section of the bulletin.

1. Replace the Transmission Control Module. Refer to *Transmission Control Module Replacement – 8L90 (MQE) transmission* on the *Control Module References* page in SI for instructions.
  - Be sure to complete TCM programming and setup after TCM replacement. Refer to *K71 Transmission Control Module: Programming and Setup (8L90 (MQE))* in SI for instructions.

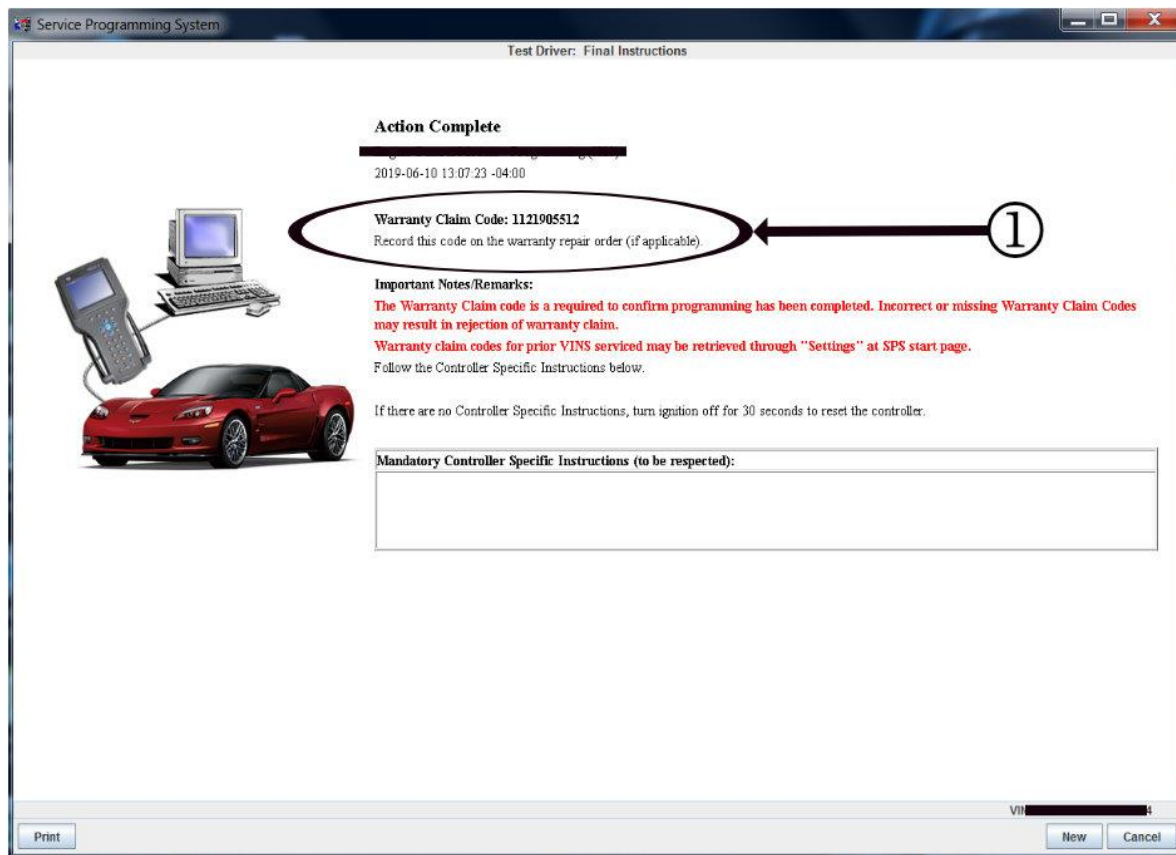
5431209

**Note:** To avoid warranty transaction rejections, you **MUST** record the warranty claim code provided on the SPS Warranty Claim Code (WCC) screen on the job card. Refer to callout 1 above for the location of the WCC on the SPS screen.

2. Record SPS Warranty Claim Code on job card for warranty transaction submission.
