GLOBAL SAFETY FIELD INVESTIGATIONS  
DCS5404  
URGENT - DISTRIBUTE IMMEDIATELY

Subject: N202300791 - Service Update  
Diesel Exhaust Fluid System Inactive

Models: 2020 Chevrolet Silverado  
2020 GMC Sierra  
Equipped with Diesel Engines (RPO L5P or LM2)

## N202300791 Diesel Exhaust Fluid System Inactive

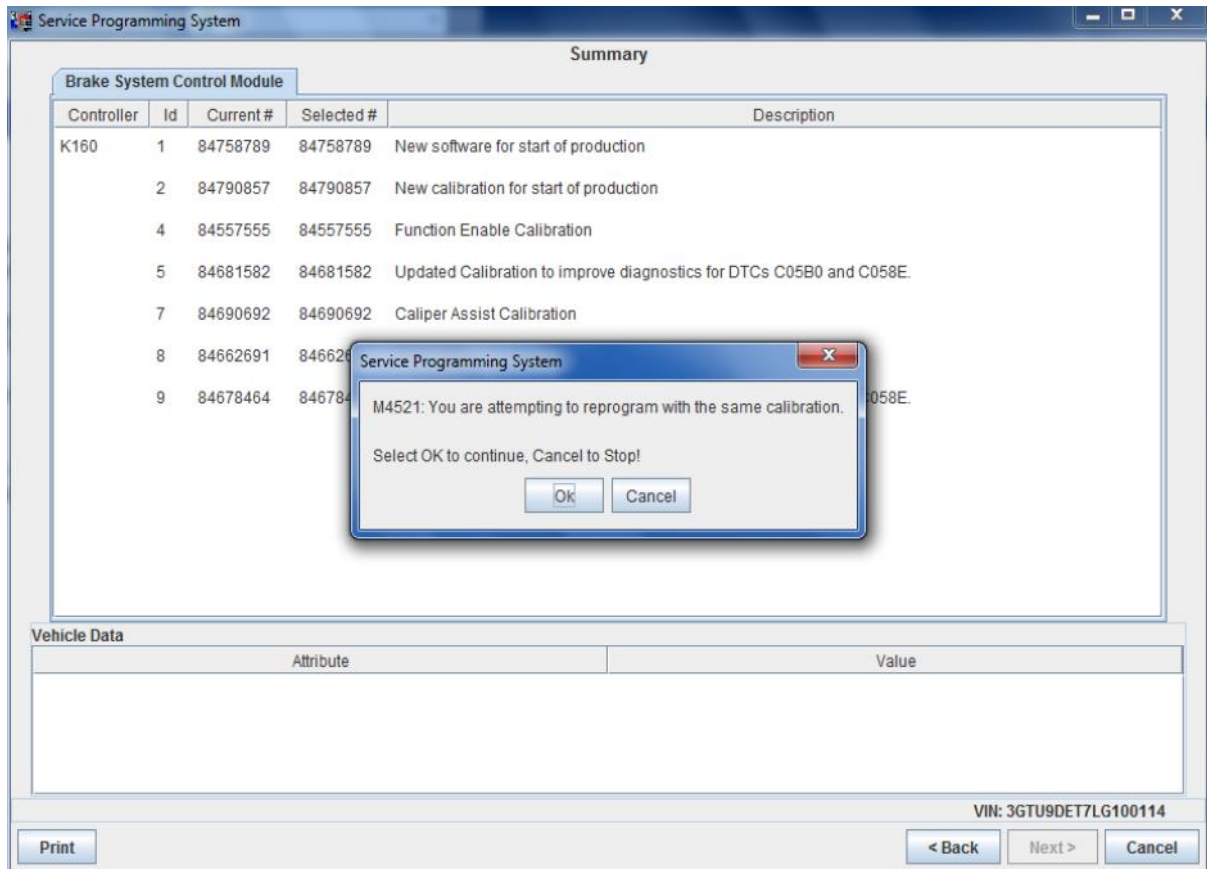
5431207

**Important:** If the Same Calibration/Software Warning is noted on the SPS screen, select OK and follow screen instructions. After a successful programming event, the WCC is located in the Service Programming System dialogue box of the SPS Summary screen. No further action is required. Refer to the Warranty section of the bulletin.

1. Reprogram the Reductant Control Module. Refer to *K115 Reductant Control Module: Programming and Setup* in SI.

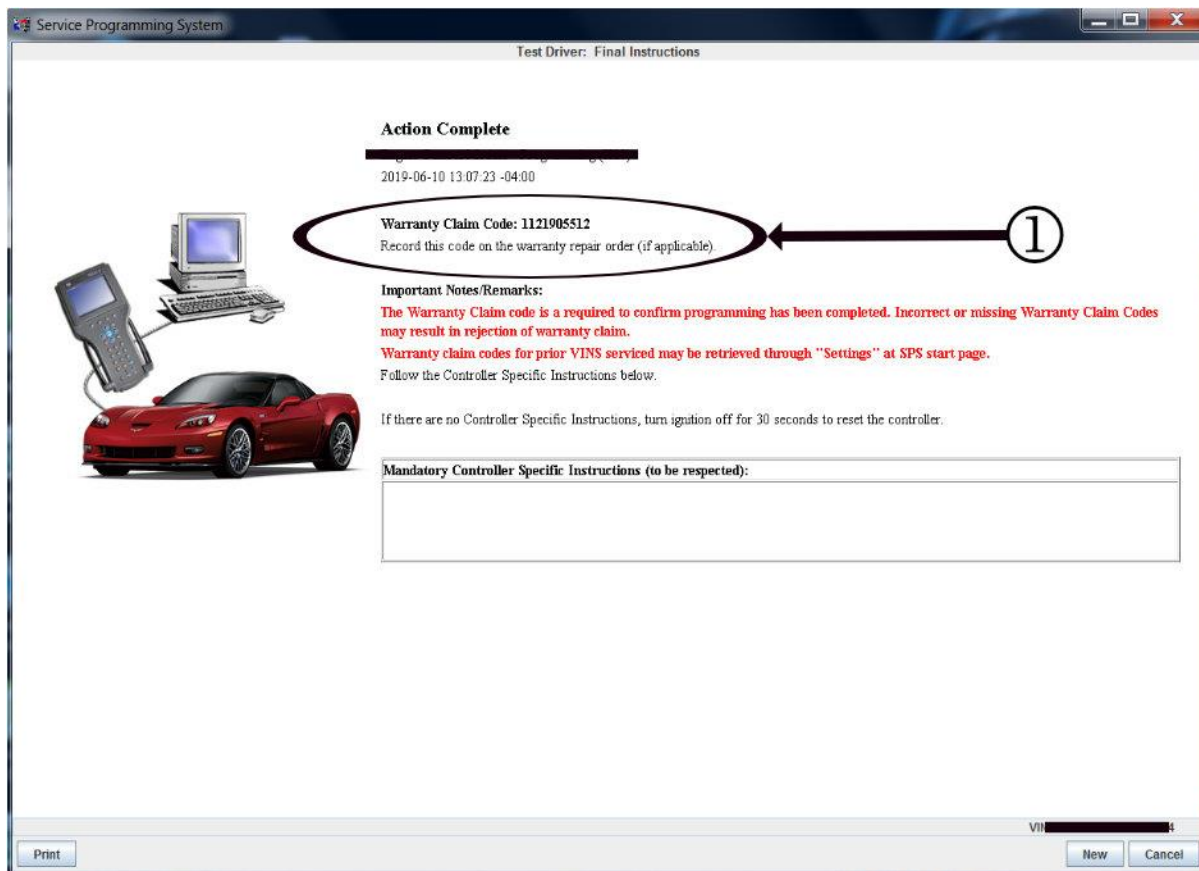
5431209

**Important:** To avoid warranty transaction rejections, you **MUST** record the warranty claim code provided on the SPS Warranty Claim Code (WCC) screen on the job card. Refer to callout 1 above for the location of the WCC on the SPS screen.

2. Record SPS Warranty Claim Code on job card for warranty transaction submission.
