Service Update

N192287840 Engine Wiring Harness Chafe

Release Date: May 2020

Condition	Certain 2020 model year Chevrolet Silverado 1500 and GMC Sierra 1500 vehicles, equipped with a 2.7L turbo engine (RPO L3B), may have a condition where the engine wiring harness may have been wrapped and/or routed incorrectly, creating the potential for wear-through in several locations. If this occurred it could allow the engine harness to short to ground and/or be severed, which may lead to a check engine light, reduced engine power, no start condition or in rare cases a stall.
Correction	Dealers are to inspect harness for correct tape wrapping and install engine harness sleeves.

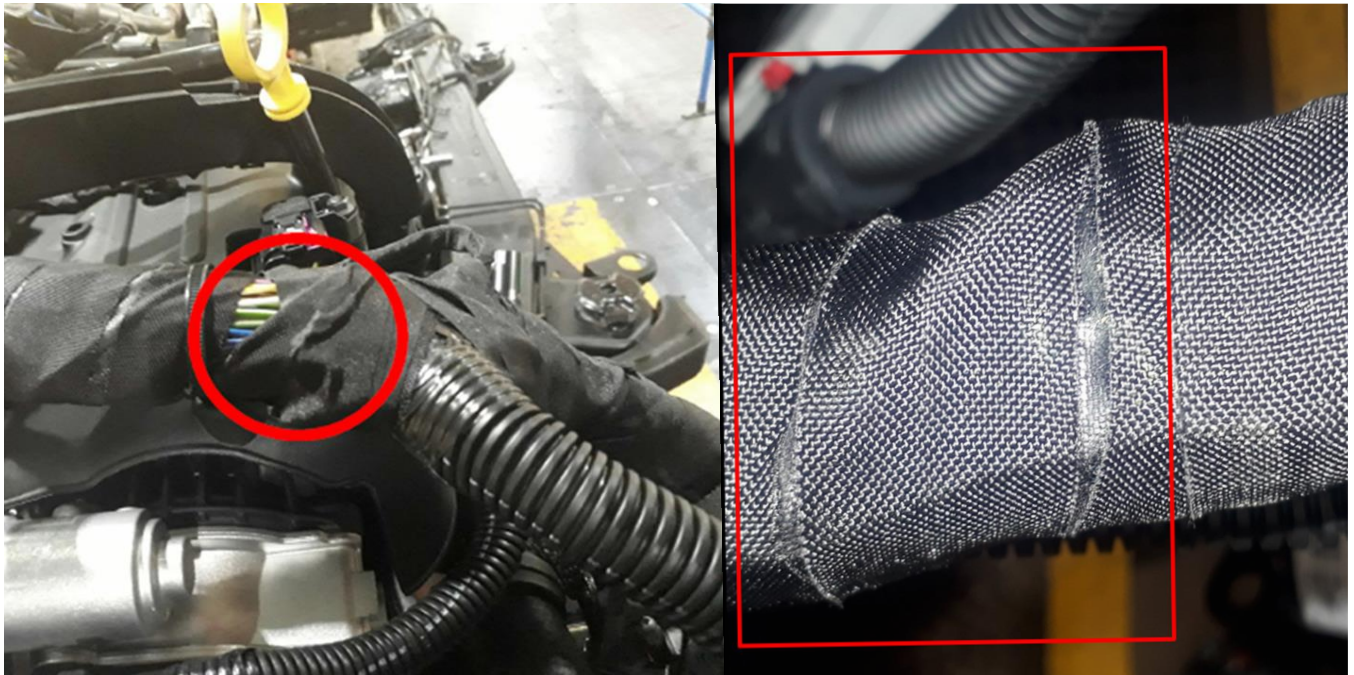
5591846

5. Inspect the engine harness across the camshaft cover as shown, being sure to inspect all the way around the engine harness.
 - Inspect for any damage where the harness or wires may have rubbed through.

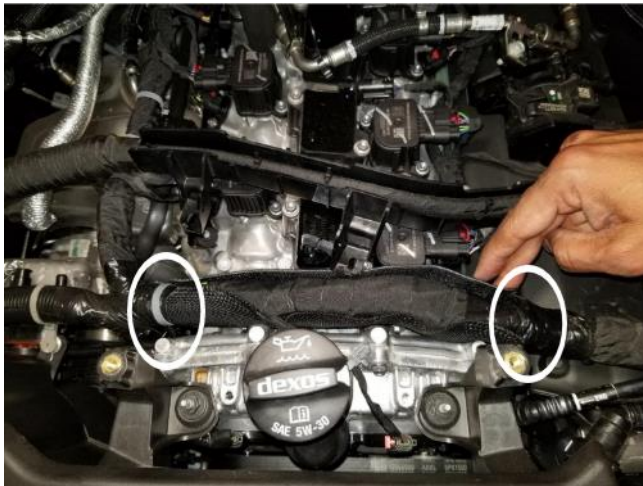
5392844

- Also inspect for mis-wrapped areas of PET tape, as shown. The PET tape should cover the entirety of the harness and there should be no gaps.
- Repair as required. Refer to *Wire to Wire Repair* in SI for any wire rub throughs and ensure that any existing gaps in PET tape coverage are rewrapped so that there are no exposed wires in the harness.

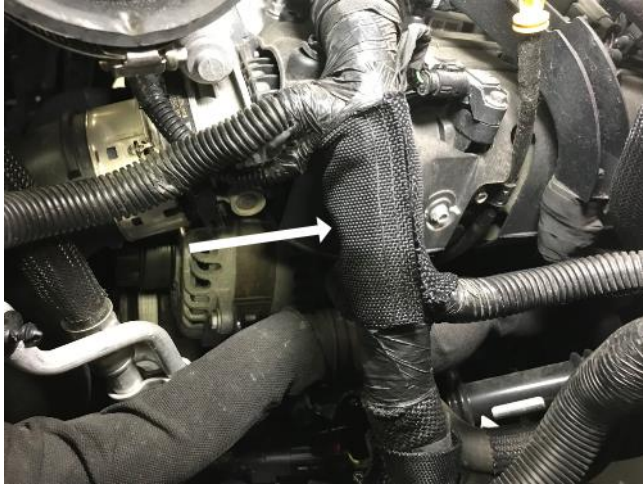
5386383

Important: Be sure the protective sleeve is installed past the lower control arm washers (1) to prevent any damage to the engine harness.

12. Install the protective sleeve around the lower engine harness as shown (near the shock tower and control arm).
