**Noise Symptom - Creaking Noise can be Heard When Touching the Steering Wheel Cover:  
Reworking Front Steering Wheel Cover (SY 87/20)**

Model Line: **Taycan (Y1A)**

Subject: **Front steering wheel cover**

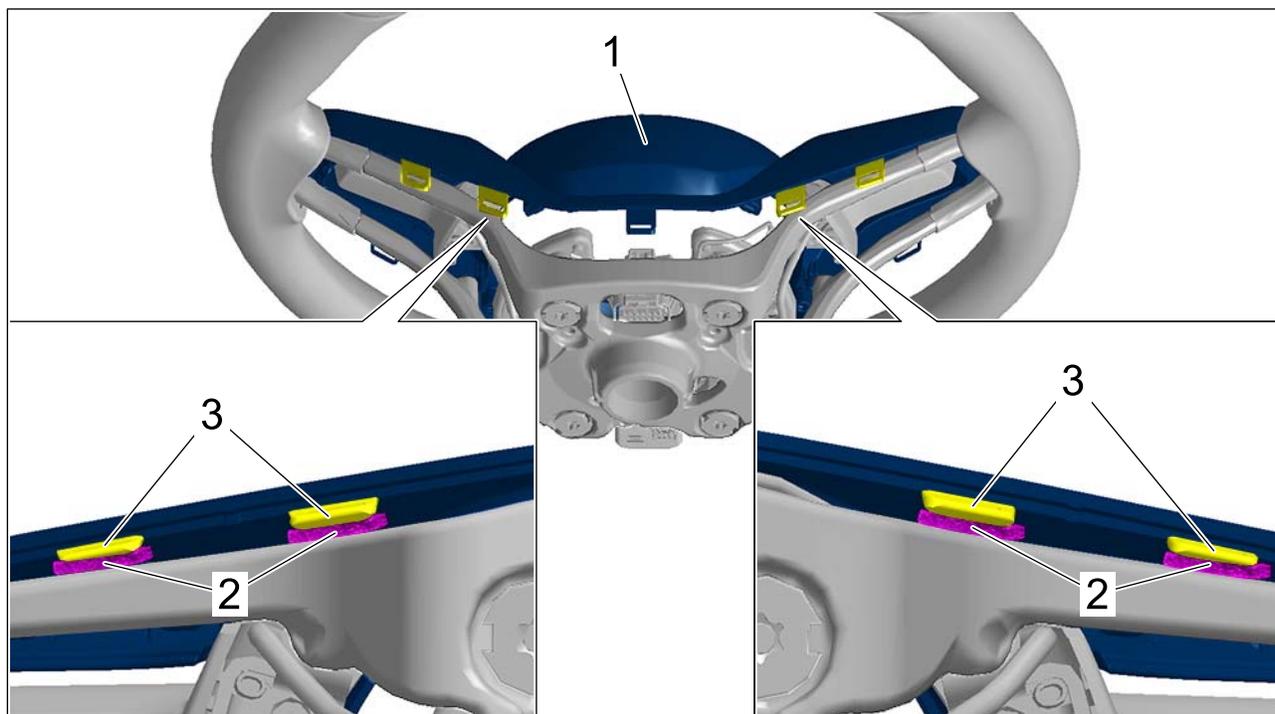
Front steering wheel cover

Cause: Play between front and rear steering wheel covers.

- 2 Reworking front steering wheel cover ⇒ *Front steering wheel cover -1-*.
  - 2.1 Cut the felt strip ⇒ *Front steering wheel cover -2-* to length.
  - 2.2 Affix the felt strip ⇒ *Front steering wheel cover -2-* to the underside of the clip connections ⇒ *Front steering wheel cover -3-* to achieve sufficient pretension.
