Y1A Charging Interrupts with Delta Wallbox Chargers

Models	Model Year	Model Type	VIN Range	Vehicle-Specific Equipment
Taycan	2020	Y1A	N/A	N/A

Revision	Release Date	Changes
0	June 29, 2020	Original document

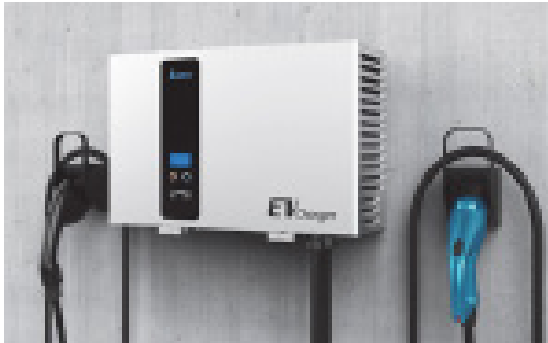
During charging sessions on Delta DC Wallbox EV Charger, interruptions may occur at different vehicle state of charge.

Due to a software issue in the Delta DC Wallbox EV Charger, a communication request from the vehicle may not correctly be answered by the charger. This may result in the vehicle ending the charging process prior to reaching the desired state of charge.

If a Taycan experiences an interrupted charging session on a Delta DC Wallbox EV Charger, the charging session may be manually restarted. No repairs should be attempted at this time. Once a resolution is available, this bulletin will be updated.
