# Technical BULLETIN

## CERTAIN 2020 YZ250FX MODELS

### Rich Running Condition - ECU Reprogramming

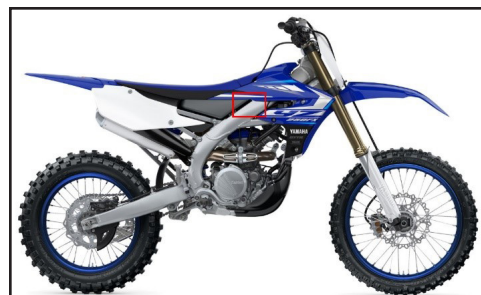
**Cause:** The 2020 YZ250FX's ignition timing and air / fuel ratio were set to meet this model's target of good low speed torque for off-road closed-course competition. When riding in certain conditions, the slightly retarded ignition timing and richer air / fuel mixture may lead to the spark plug fouling, causing a hard-starting condition.

Original ECU Programming

Revised ECU Programming

**Remedy:** To remedy this condition, Yamaha has revised the ECU programming to address the rich running condition.
