MODEL
2020MY
Telluride (ON)

NUMBER
PS664

WINDOW LOGIC: INITIALIZATION PROCEDURE

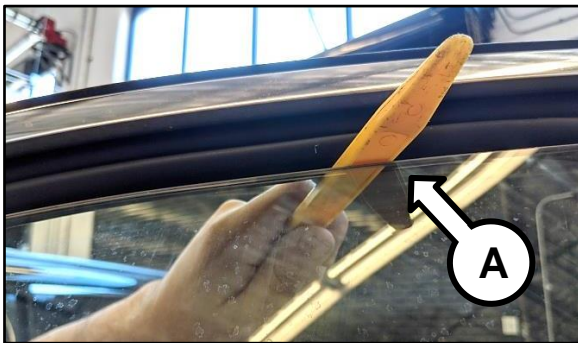
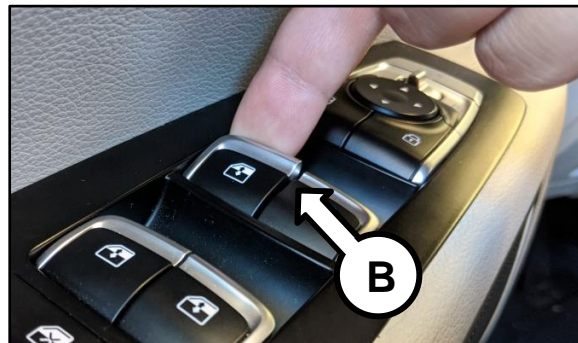
This Pitstop provides information regarding the door window logic on some 2020MY~ Telluride (ON) vehicles, by design to improve wind noise, the window glass may lower 5 - 10 cm below the top door frame weather strip when the window is being closed. This is normal operation. However, if the door window does not remain in the closed position when utilizing Auto-Up feature, then a re-initialization may be needed to resolve the customer complaint. It is important to note that a capacitive discharge (battery disconnect) may not be sufficient in resetting door window motor memory. Failure to follow the procedure outlined in this Pitstop can result in a warranty claim chargeback for unnecessary part replacement.

1. Lower the door window glass by pressing down on the door switch.
2. Place a trim tool (A) between the glass and frame as shown below and hold firmly.

3. Pull the Auto-Up door switch (B) up until the glass window comes in contact with the object, the window glass will automatically cycle down about halfway due to Anti Pinch Function.
4. Repeat Step 3, for a total of 3 times. After the 3rd time, the Auto-Up function should no longer work, which is an indication that the memory has cleared.
5. Press the door switch UP and hold the UP switch for 2-3 seconds after the window is closed.
6. Cycle the power window glass down & up fully to confirm that power window motor(s) has been initialized.
