MODEL
**2019-2021
Multiple Models
with IVT**

NUMBER
200 (Rev 1, 06/29/2020)

TECHNICAL SERVICE BULLETIN

**SERVICE ACTION: IVT SOFTWARE LOGIC
IMPROVEMENT AND/OR IVT REPLACEMENT (SA424)**

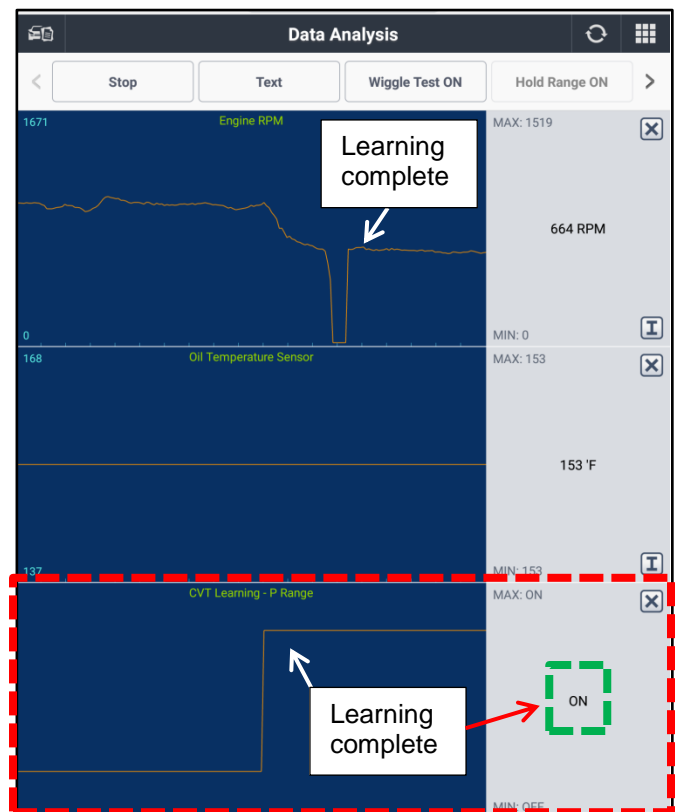
16. Start the engine to confirm proper operation of the vehicle.
17. If MIL with DTC P160300 is present **after** verifying and completing the '**Resetting Auto Trans Adaptive Values**' procedure, then proceed to replace the IVT outlined on page 10.
