GROUP ENG	MODEL 2017-19MY Niro (DE P/HEV)
NUMBER	DATE
212	June 2020

# TECHNICAL SERVICE BULLETIN

## SUBJECT: CYLINDER HEAD REPLACEMENT FOR LEAN MISFIRE

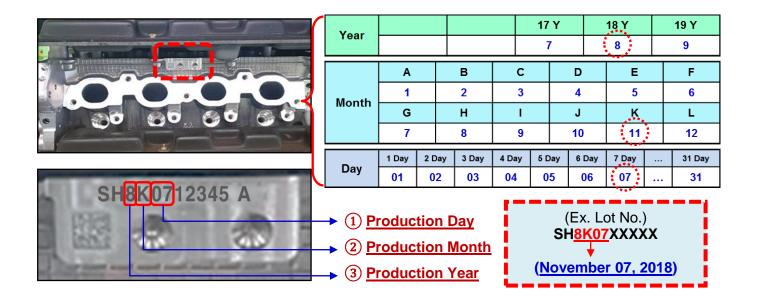
Locate the cylinder head **Lot Number** shown below and verify the cylinder head was produced within the production date listed in the table above.

This repair ONLY applies if the existing cylinder head was produced on <u>or</u> before November 7, 2018.
