<b>Subject:</b>  <b>CHECK ENGINE LIGHT ON WITH DTC P2229:00</b>	<b>Bulletin No.:</b> 01-008/20
	<b>Last Issued:</b> 06/05/2020

2018-2020 Mazda6 (US spec with SKYACTIV-G 2.5T) with VINS lower than JM1GL\*\*\*\*\*521425 (produced before December 27, 2019)

2019-2020 Mazda6 (Mexico spec with SKYACTIV-G 2.5T) with VINS lower than JM1GL\*\*\*\*\*521378 (produced before December 27, 2019)

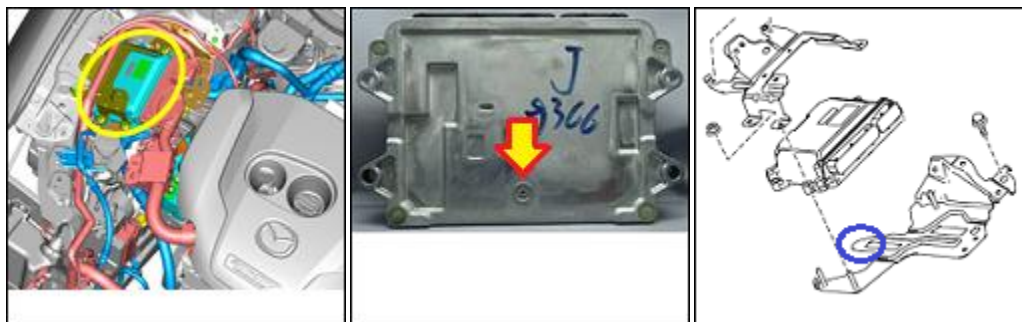
This concern will most likely occur on vehicles that have aftermarket wax applied in the engine compartment. Aftermarket wax applied in the engine compartment may adhere on the breather hole located at the bottom of the PCM, which may collect dust and result in a plugged filter. This breather hole is actually a filter for the air pressure sensor in the PCM. When the PCM gets hot, the internal air pressure may rise due to the plugged filter and result in DTC P2229:00.

To eliminate this concern, the shape of the PCM bracket has been modified to not cover the breather hole and eliminate a gap between it and the PCM that may promote the residual liquid wax.
