Technical Service Bulletin

Subject: FRONT BUMPER CRACKED NEAR THE FRONT FENDER/FRONT COMBINATION LIGHT	Bulletin No.: 09-022/20
	Last Issued: 06/26/2020

2016-2019 CX-9 vehicles with VINs lower than JM3TC*****306028 (produced before September 17, 2018)

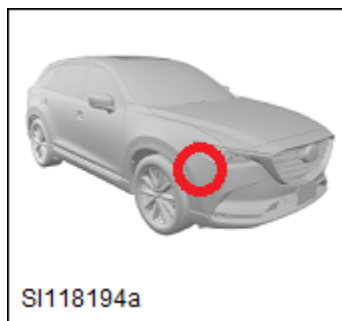
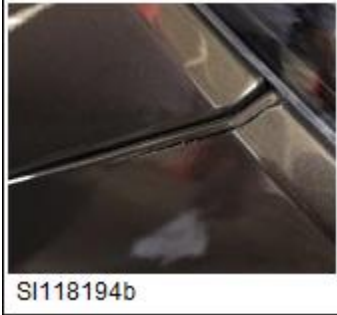
Some customers may notice cracks (as shown below) at one or both ends of the front bumper near the front fender / front combination light. This may be caused when driving over bumps. The bumper fascia may receive higher than expected forces, depending on driving manner and road conditions. To eliminate this concern, the internal shape and material of the front bumper fascia has been modified.

1. Verify the customer concern.
2. Replace the front bumper cover with a modified part according to the instructions on MGSS online:
