Business Class M2
> Cascadia
108SD/114SD
> New Cascadia

**Freightliner
Service Bulletin**

31-041

Chassis Side-Fairing Kickplate Magnet Replacement

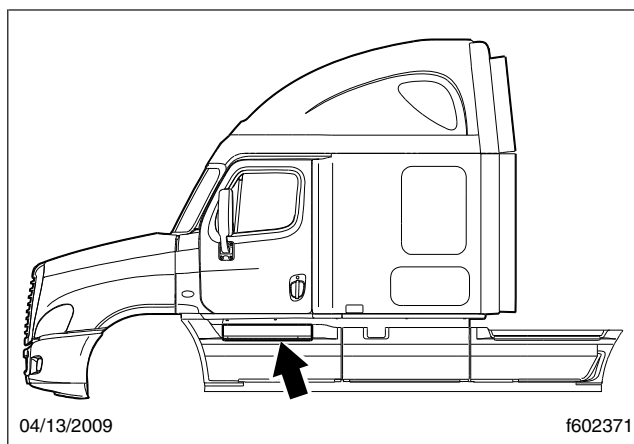
On Freightliner Cascadia and New Cascadia vehicles manufactured before May 20, 2019, and equipped with side-fairings, the magnets that hold the kickplate closed may corrode and prevent the kickplate from staying in the closed position. See **Fig. 1** for the location of the kickplate. If a magnet is found to be corroded it is recommended that all of the components that make up the magnet assembly be replaced. Order the parts in **Table 1** and follow the instructions below to replace both kickplate magnet assemblies.

Fig. 1, Kickplate Location

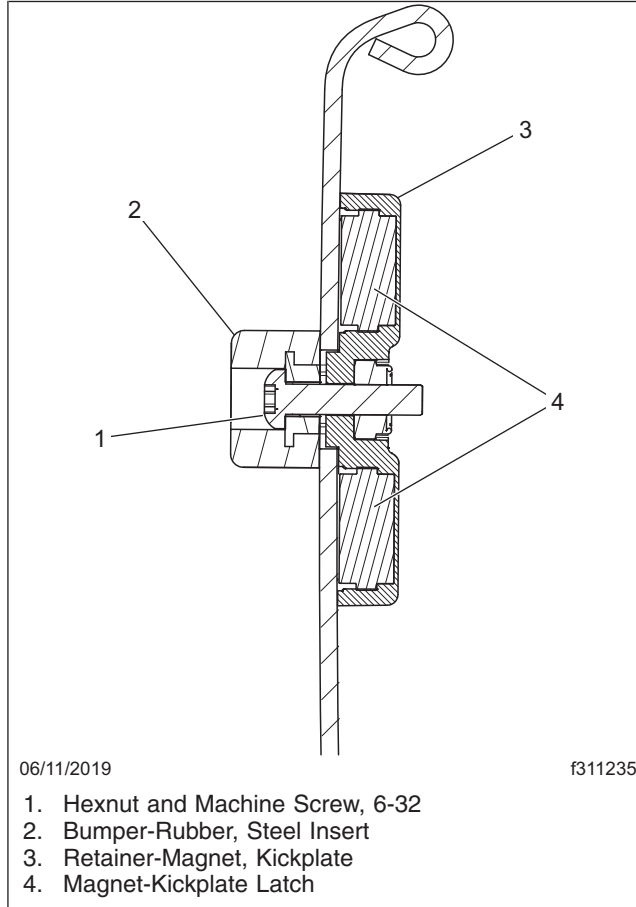
Fig. 2, Rubber Bumper and Magnet Assembly

3. Drill out the rivets that hold the striker plate and remove the striker plates.
4. Install the new magnets in the new retainers.
5. Using the machine screw and hexnut, install the new rubber bumper and magnet assembly. See **Fig. 2**.

6. Using the rivets, install the new striker plate.
