Constellation  
Heritage  
4700 Models  
4800 Models

Western Star  
Service Bulletin

## General Information

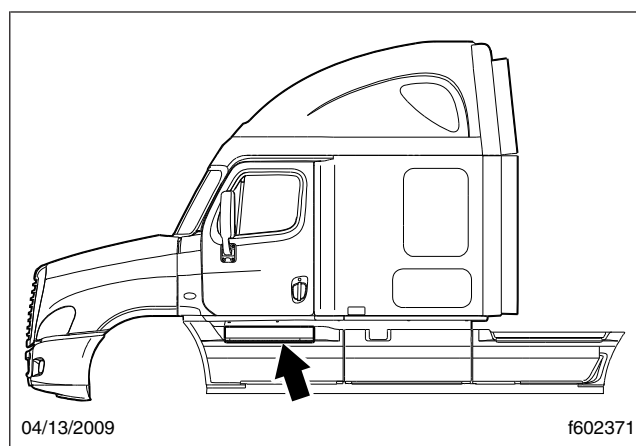
**Fig. 1, Kickplate Location**

On Western Star 5700 vehicles manufactured before May 20, 2019, and equipped with side-fairings, the magnets that hold the kickplate closed may corrode and prevent the kickplate from staying in the closed position. See **Fig. 1** for the location of the kickplate. If a magnet is found to be corroded it is recommended that all of the components that make up the magnet assembly be replaced. Order the parts in **Table 1** and follow the instructions below to replace both kickplate magnet assemblies.
