Business Class M2
Cascadia
108SD/114SD
> New Cascadia

Freightliner
Service Bulletin

Compressor Bracket Modification to Reduce Harness Chafing

54-330

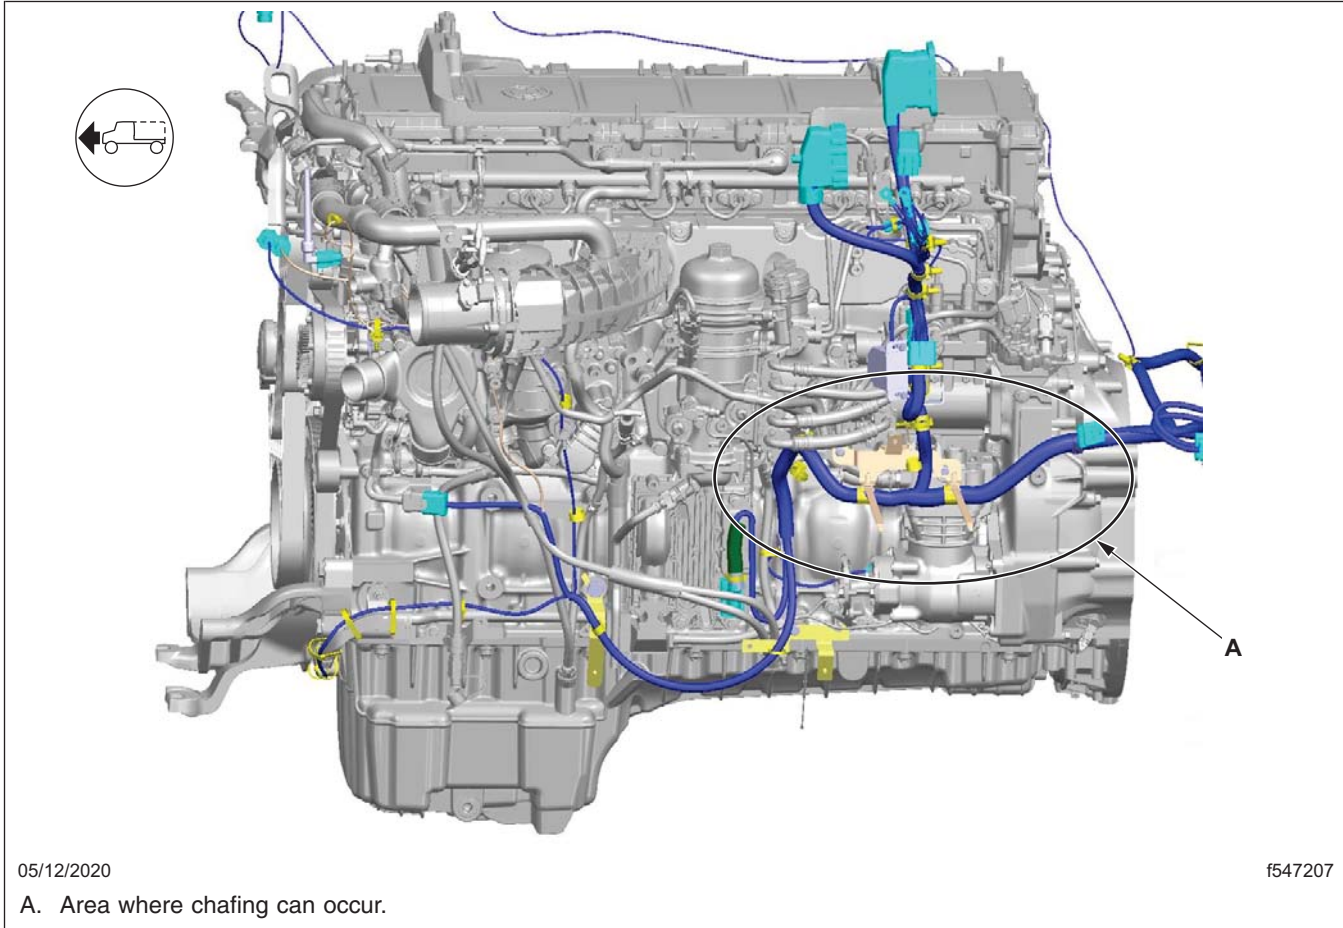
New Cascadia vehicles with Detroit HDEP engines may experience engine harness chafing at the harness support bracket that mounts on the air compressor. To avoid this issue, a new hole is drilled on the bracket to enhance the spacing with tie straps and reduce harness contact with the mounting bolt. Additional harness wrapping is added to reduce the harness chafing. The following are the possible symptoms that associate with this issue which may include one or more of these.

Fig. 1, Area of Concern for Harness Chafing

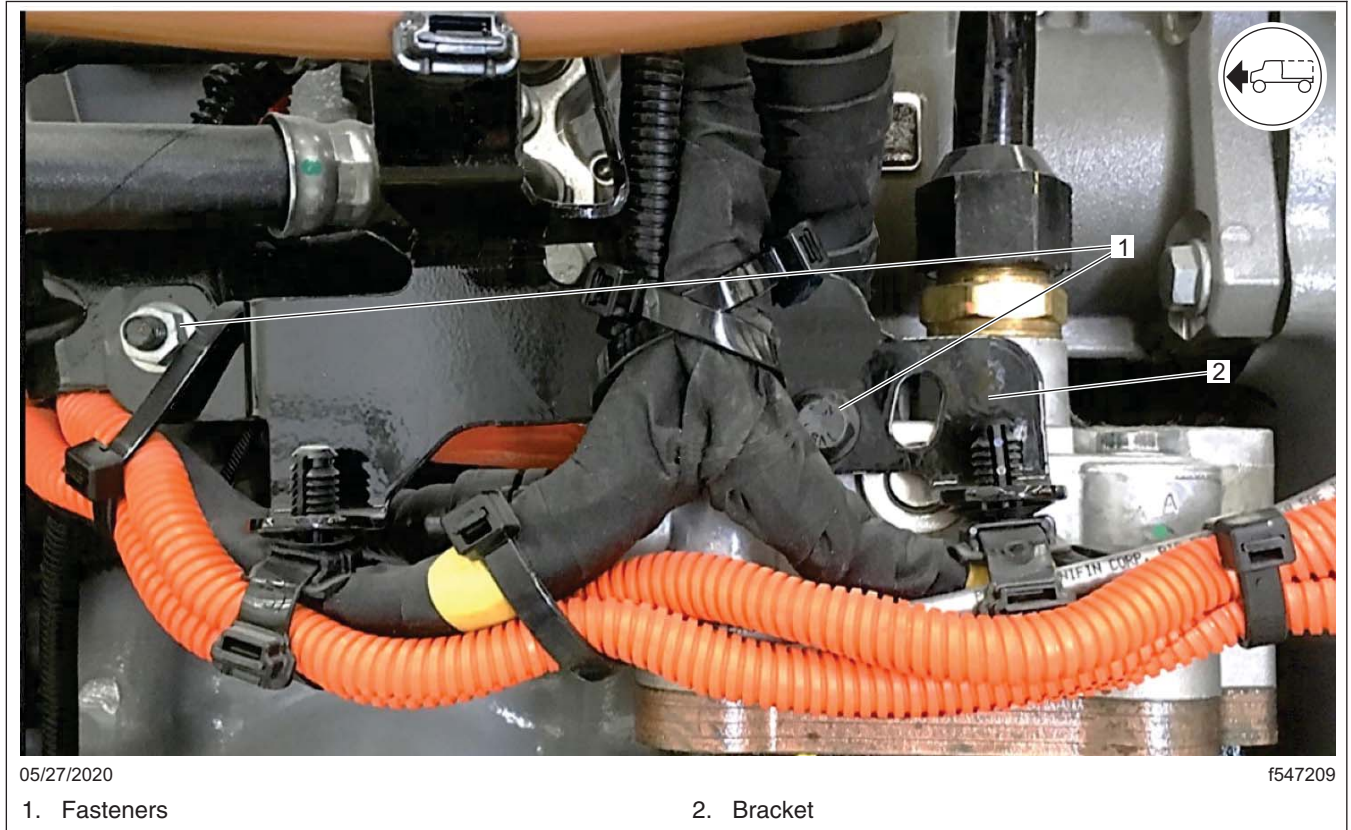
Fig. 2, Harness Near the Air Compressor Mount Bracket

5. Remove the fasteners and then remove the bracket from the engine. See **Fig. 2**.

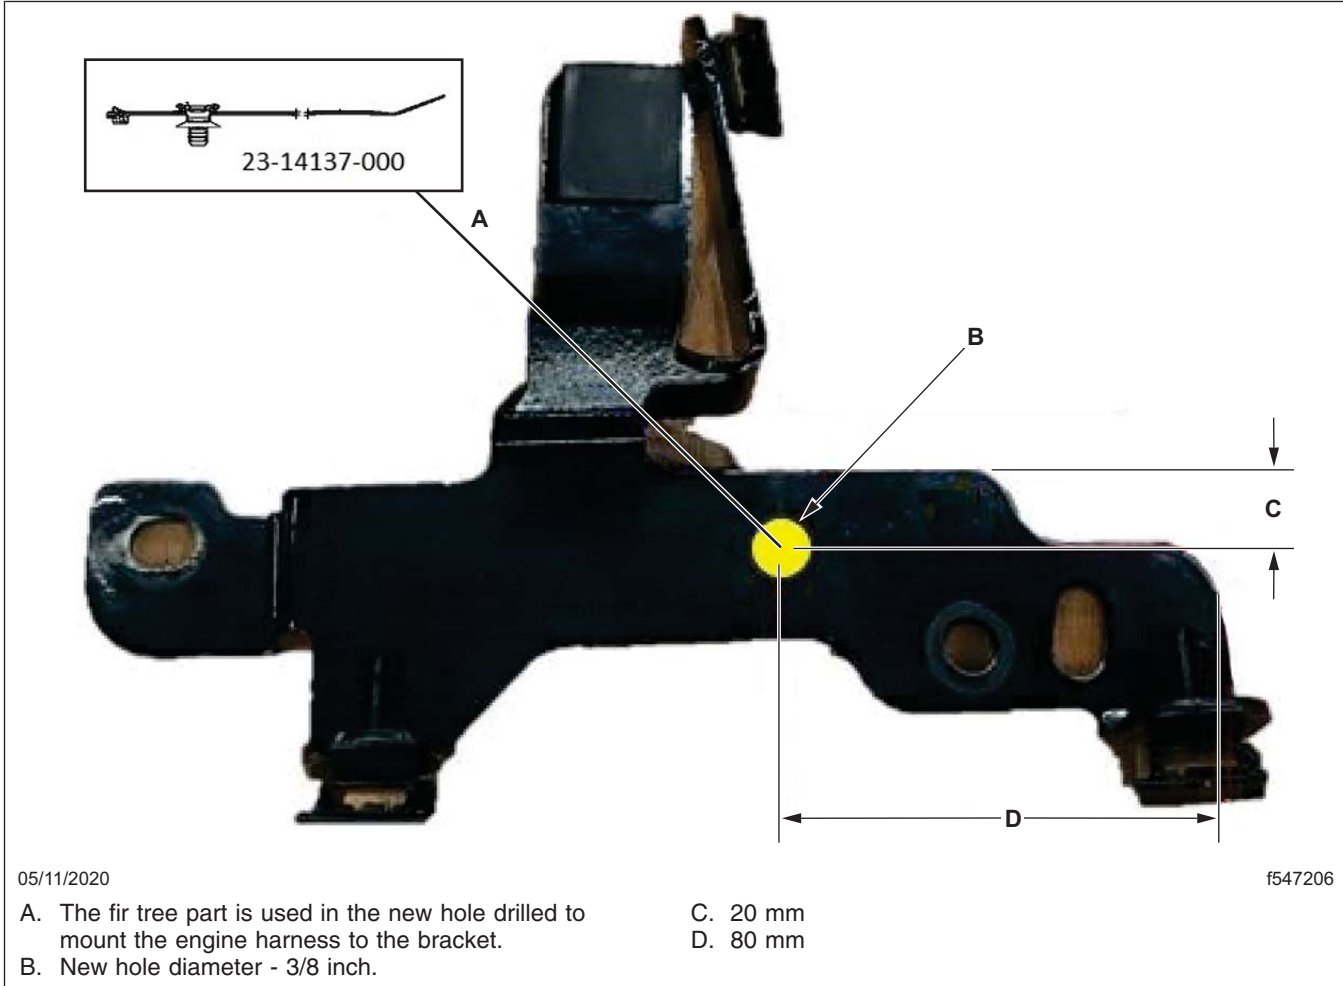
Fig. 3, New Hole Dimensions on the Bracket

6. Using [Fig. 3](#) as a reference, drill a 3/8 inch hole in the bracket.

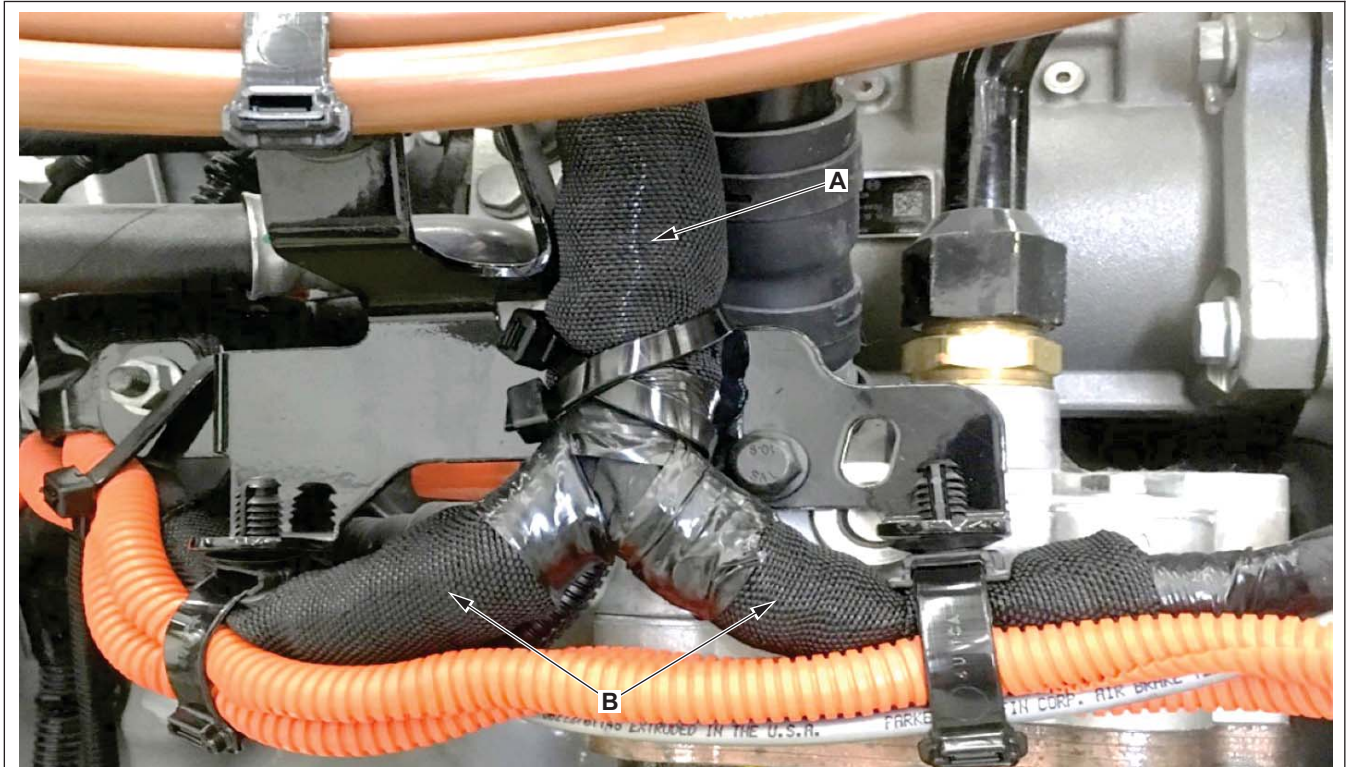
Fig. 4, Twist Tube Cover

7. Add an appropriate sized twist tube to the vertical and horizontal sections of the engine harness as shown in Fig. 4. Allow enough twist tube length to cover the harness at all of the bracket clipping points. Secure each end of the twist tube with electrical tape.

A. Use 19 mm or 22 mm twist tube for this area.

B. Use 13 mm twist tube for these areas.

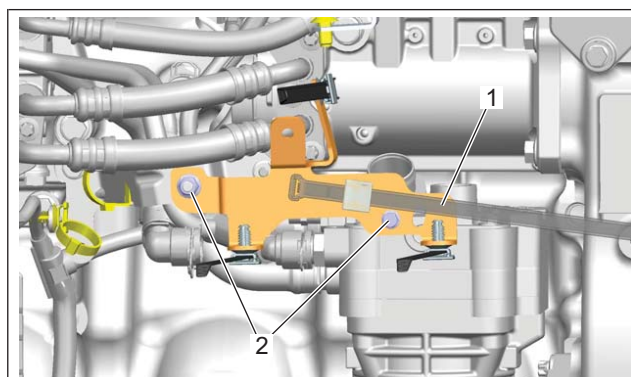
Fig. 5, Newly Drilled Bracket with Tie Strap

8. Install the newly drilled bracket with the fastener. Then, install a fir tree with tie strap (23-14137-000) into the new hole being used to fasten the harness to the bracket. See [Fig. 5](#).

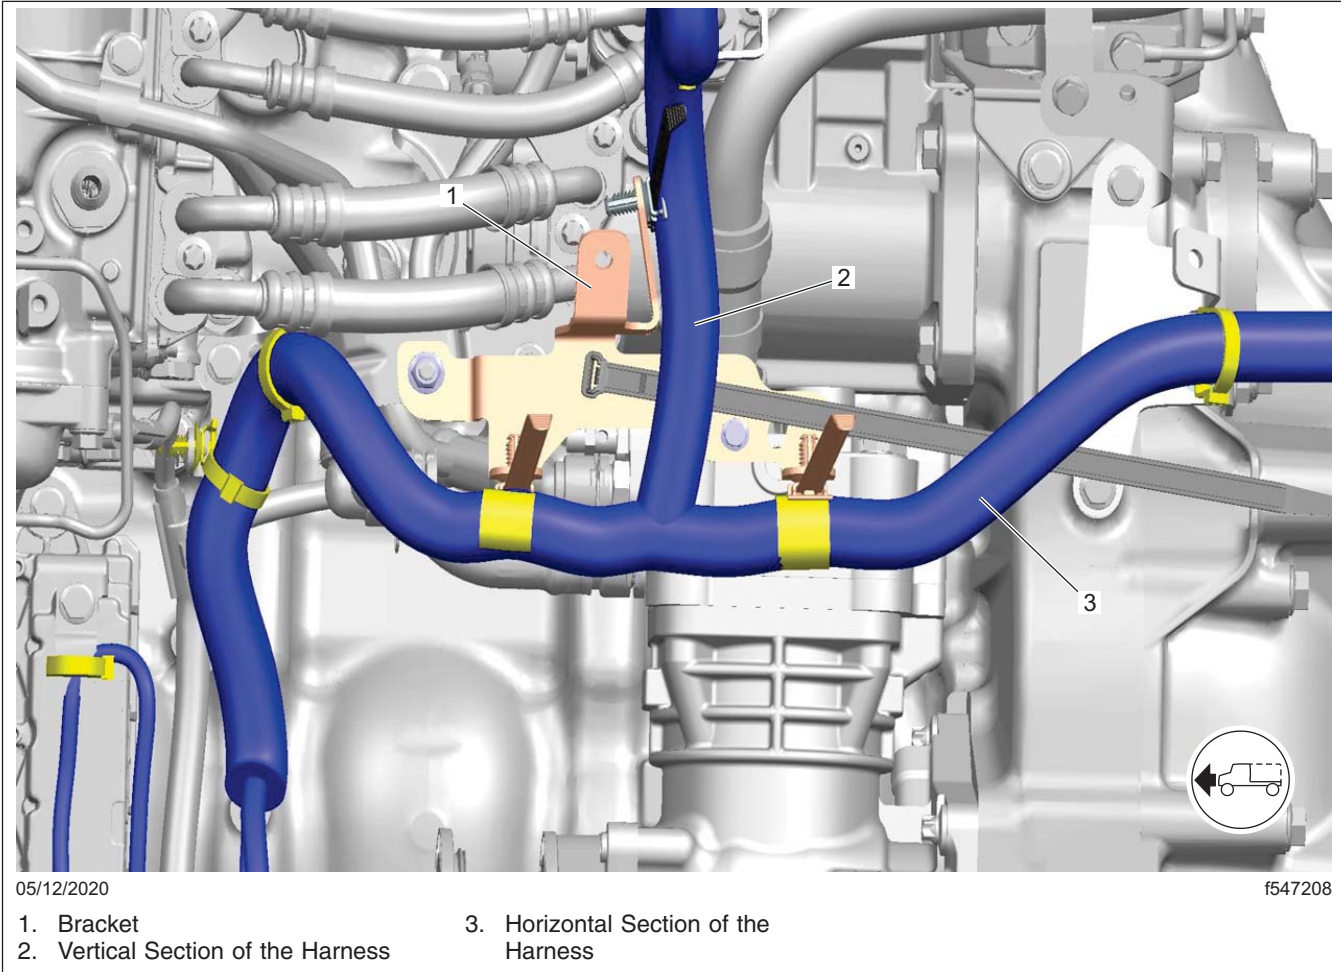
Fig. 6, Securing the Harness to the Bracket

9. Secure the engine harness to the bracket using the fir tree and tie strap. See **Fig. 6**.
