Service Alert

Subject: MAZDA CONNECT SYMPTOM TROUBLESHOOTING [6TH GENERATION VEHICLES]	Service Alert No.: SA-026/20
	Last Issued: 06/11/2020

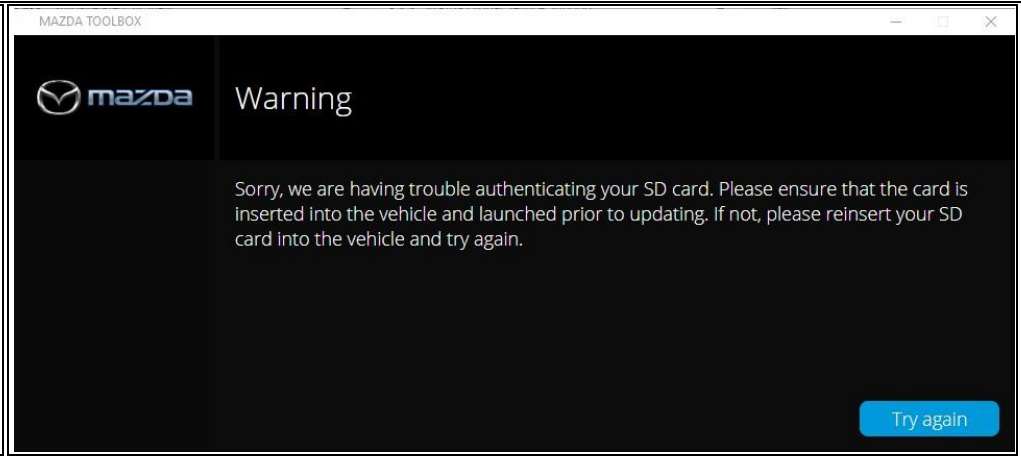
<p>Navi SD Card VIN Unlocked (Mazda Toolbox will not read card)</p>
