Subject: CONNECTED VEHICLE SYMPTOM TROUBLESHOOTING	Service Alert No.: SA-031/20
	Last Issued: 06/01/2020

2020 Mazda3
2020 CX-30

DESCRIPTION

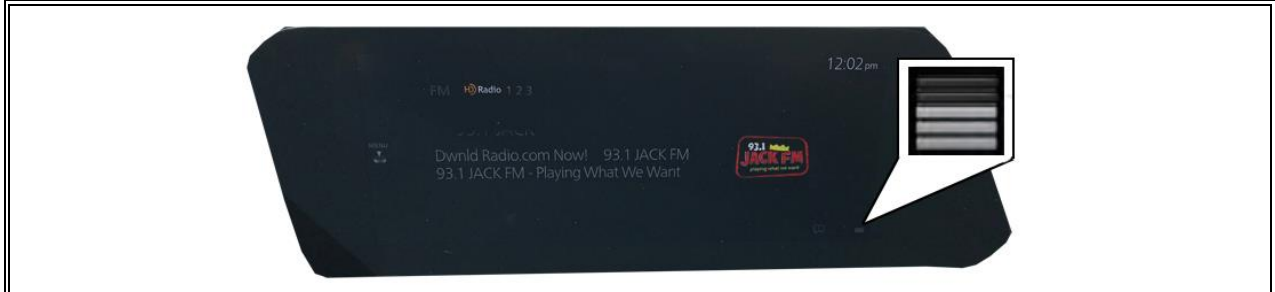
Confirm the customer's phone and vehicle have good to strong reception during the concern as shown in the table below.

Radio waves are not being received. Move to a location with good reception.

Weak reception.

Good Reception

Strong reception.

- If the reception is weak, move the vehicle to a location where the reception is good to strong as shown in the table, then try to get the One Time Pass Code and/or operate the remote functions before proceeding to the Repair Procedure if there is still an issue.
- If the reception is good to strong, proceed to the Repair Procedure.
