Service Alert

Subject: FORWARD SENSING CAMERA (FSC) DYNAMIC AIMING NOT COMPLETED AND/OR DTC B14F0:76 STORED	Service Alert No.: SA-046/20
	Last Issued: 06/23/2020

2019 - 2020 MAZDA3
2020 CX-30

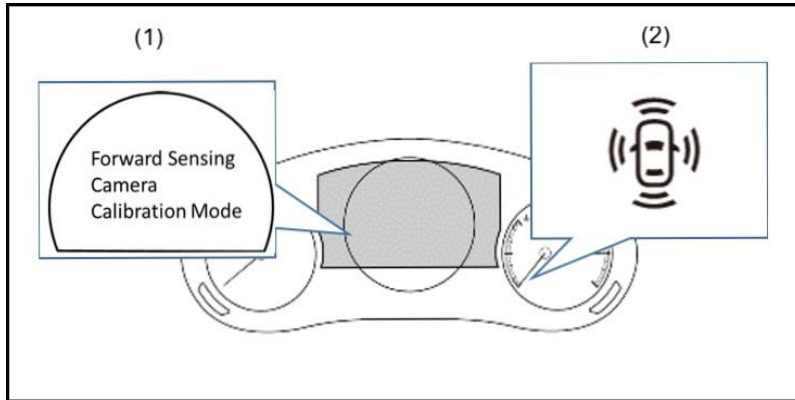
FSC dynamic aiming is completed if the following conditions are met:

1. "Forward Sensing Camera Calibration Mode" message (1) on instrument cluster MID disappears.
2. The i-ACTIVSENSE warning light (2) turns off.
3. Steps 1 and 2 are completed within 20 minutes from start of aiming.

- FSC dynamic aiming mode is finished after 20 minutes due to time limit, regardless of aiming completion.
- If FSC dynamic aiming cannot complete or the "FSC in calibration mode" message returns, perform stationary aiming (static aiming).
- If FSC aiming is unsuccessful and DTCs B14F0:04 and/or B14F0:76 are stored, perform BCM configuration and then redo FSC aiming.
