Service Alert

Subject: ENGINE NO START DUE TO LOW BATTERY VOLTAGE	Service Alert No.: SA-054/20
	Last Issued: 06/26/2020

2019-2020 Mazda3
2020 CX-30

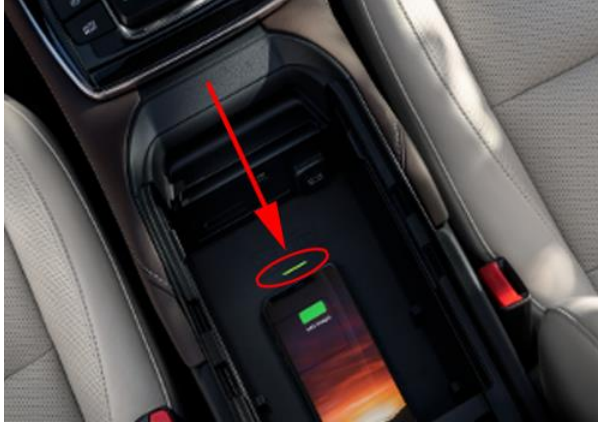
3. Turn the ignition OFF and check if the Mazda Wireless Charger LED indicator is ON?

- Yes: The Mazda Wireless Charger installation is incorrect. Replace the Mazda Wireless Charging kit and install it using the North America installation instructions (go to MXConnect - Parts and Accessories - Accessories - Genuine Mazda Accessories (GMA) - Accessory eCatalogue - Wireless Charging - Related Documents - Installation Instructions).
- No: Go to step 4.

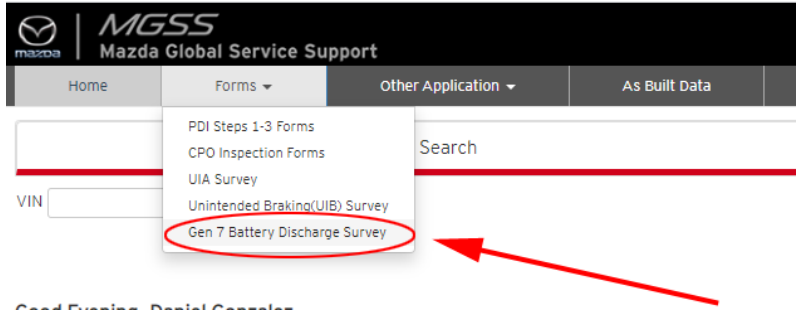
5. Complete the Battery Discharge Questionnaire (Go to MGSS Home Page - Forms - Gen 7 Battery Discharge Questionnaire) and attach the completed questionnaire to the Repair Order.
