Tesla, Inc.
Service Bulletin

Adjust Overflush Charge Port Door

SB-20-10-001

June 9, 2020

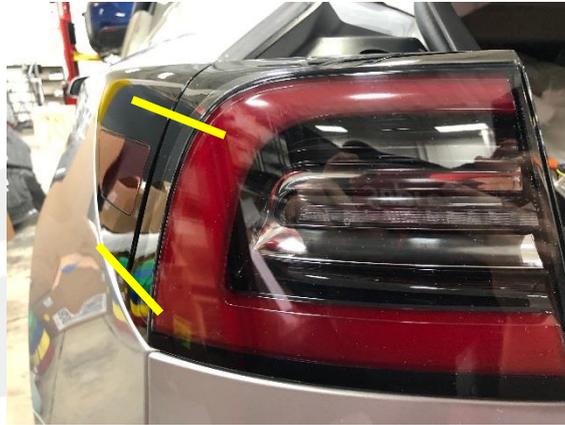
Figure 1 – Overflush check locations

1. Use a gap and flush tool to check the overflush between the charge port door and the LH taillight.

**NOTE:** Record the overflush at the top and bottom (Figure 1) of the line between the charge port door and the LH taillight. Overflush in the middle is not considered, as it is not adjustable.

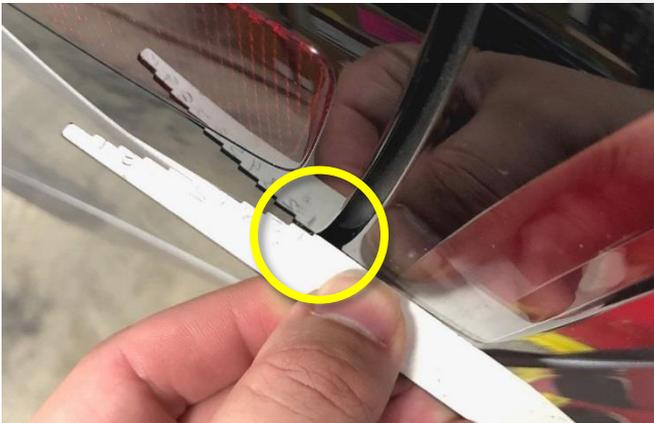
**Figure 2 – Overflush 1.5 mm or less**

- Both the top and bottom is 1.5 mm or less (Figure 2), the overflush is within specification. Discontinue this procedure.
- Either the top or bottom is greater than 1.5 mm (Figure 3), continue to the next step.

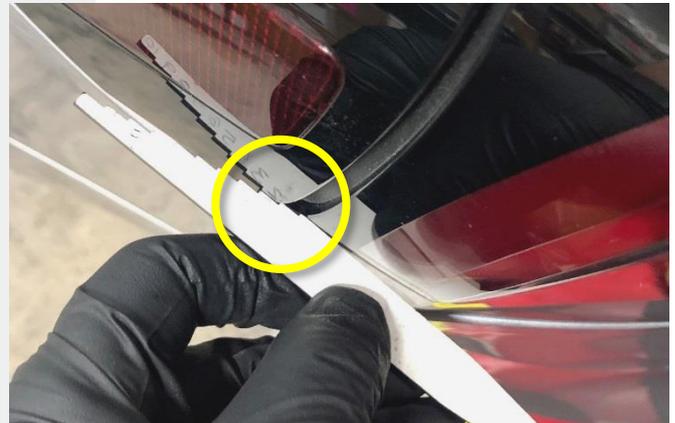
**Figure 3 – Overflush greater than 1.5 mm**

Some Model 3 and Model Y vehicles might have a charge port door that is overflush (protrudes in comparison) to the LH taillight assembly.
