Technical product information

Topic	Continental GTC - Hood insulation cover checks prior to replacement
Market area	Bentley: worldwide (2WBE)
Brand	Bentley
Transaction No.	2058465/2
Level	EH
Status	Approval
Release date

Continental GTC

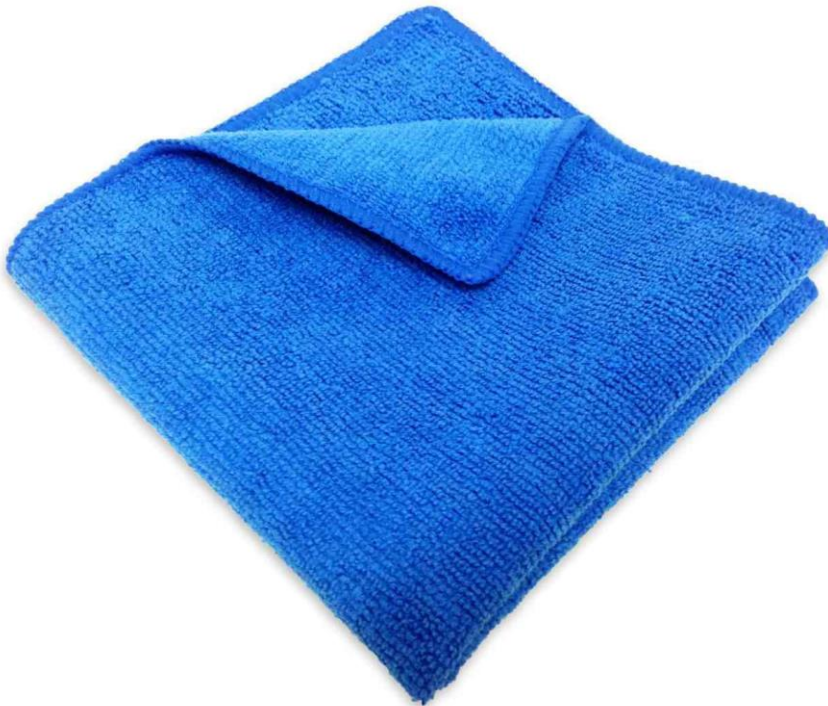
1) Should dust or debris be evident on the pad, attempt to clean the pad using a damp/slightly wet (Not soaking wet) microfiber cloth (Figure 1)

▪
Ensure the microfiber cloth used for cleaning is the type shown in Figure 1

- Allow the pad to dry
- Using a suitable vacuum cleaner – Remove any remaining dust or debris
- If NO dust and/or debris is evident after cleaning DO NOT REPLACE the pad
- If dust and/or debris is still evident after cleaning REPLACE the pad

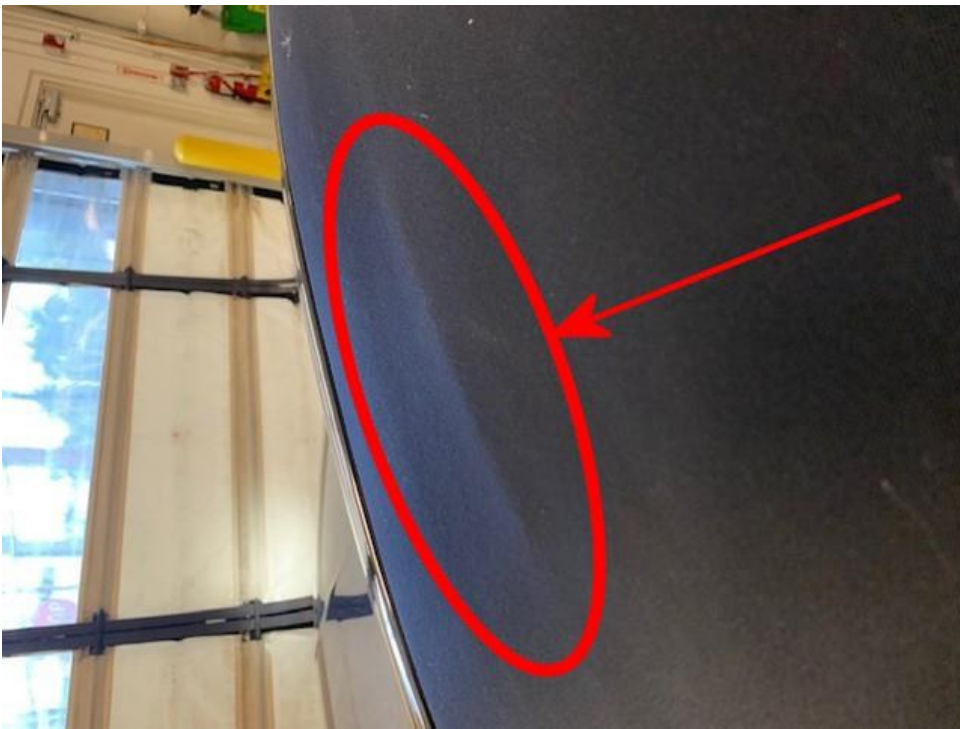
2) In the event the insulation pad is as shown in Figure 2, the insulation pad **MUST** be replaced - Refer to Rep. Gr 61 - NOTE: The issue shown in Figure 2 relates to an issue with the insulation pad rubber retainer

IMPORTANT: The instructions within TPI 2058277/1 **MUST** be adhered to when replacing the insulation pad

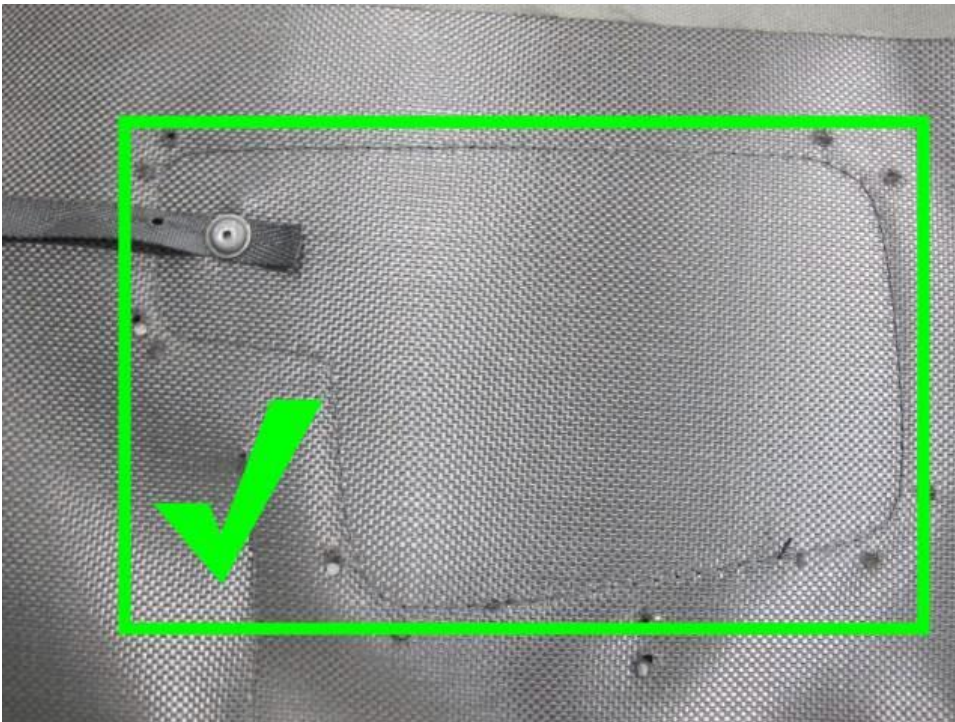
3) Referring to Figure 3 - Check and confirm the insulation pad plastic paddles are not broken – missing or damaged IMPORTANT: the operative should confirm the paddles are flat, not bent or broken at any location

IMPORTANT: There is no requirement to replace the insulation pad should the plastic paddles not be broken - missing or damaged the example shown in Figure 3 is to specification and exhibits no issues

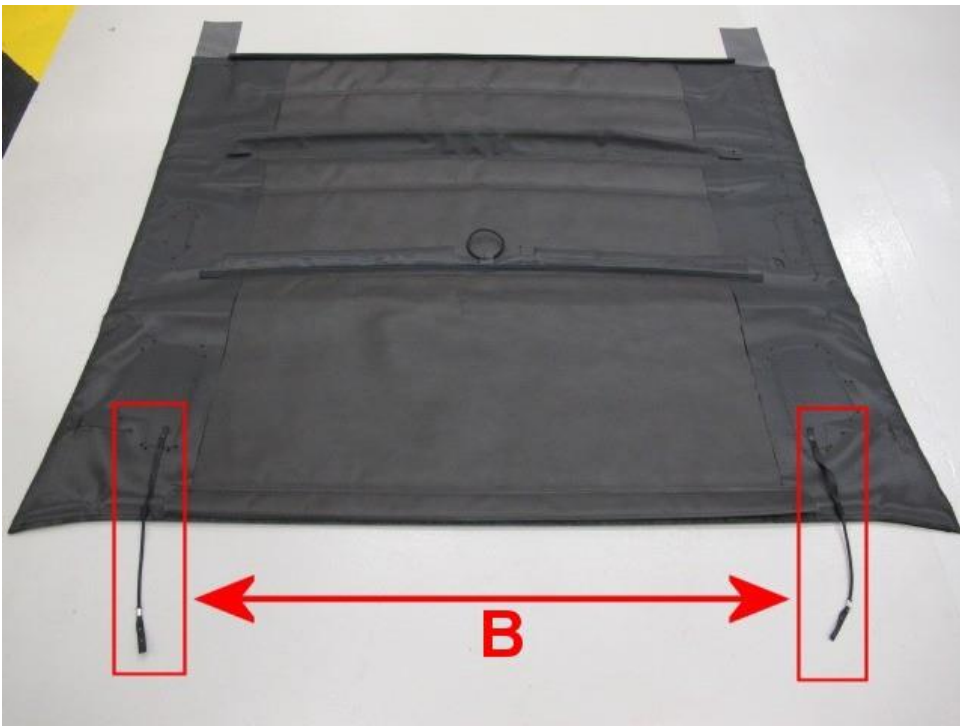
- Referring to Figure 4 - Check and confirm the tension straps are fitted to the insulation pad as shown

- In the event the tension straps are not fitted – Refer to the instructions within TPI2058277/1
