# Technical Service Bulletin

GROUP <b>CAMPAIGN</b>	NUMBER <b>20-01-027H</b>
DATE <b>JUNE, 2020</b>	MODEL(S) <b>SONATA (DN8)</b>

**SUBJECT:** ECM SOFTWARE UPDATE – P030X & P0456 (SERVICE CAMPAIGN T5A)

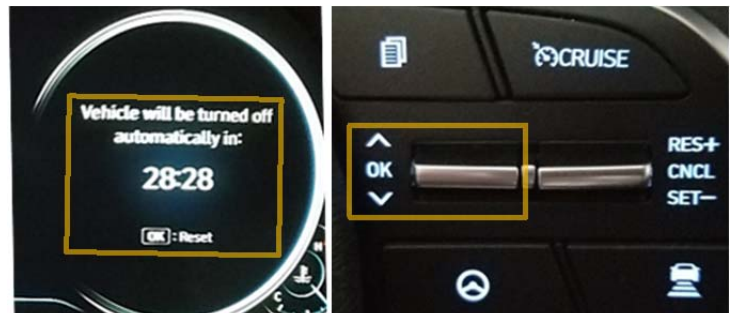
The ECM Software Update takes approximately 15 minutes to perform. However, the vehicle is equipped with a 30 minute factory default Vehicle Auto-Shut Off feature.

If the **Vehicle Shut-Off Timer: XX:XX** appears on the cluster, press **OK** on the steering wheel to reset the timer before starting the ECM update.

In the event of ECM update failure due to Vehicle Auto-Shut Off activation, perform the ECM update again in **Manual Mode**.
