## Technical Service Bulletin

20-01-028H

Elantra (AD/ADa)

ECU & TCU UPDATE AND IVT REPLACEMENT  
(SERVICE CAMPAIGN T5B)

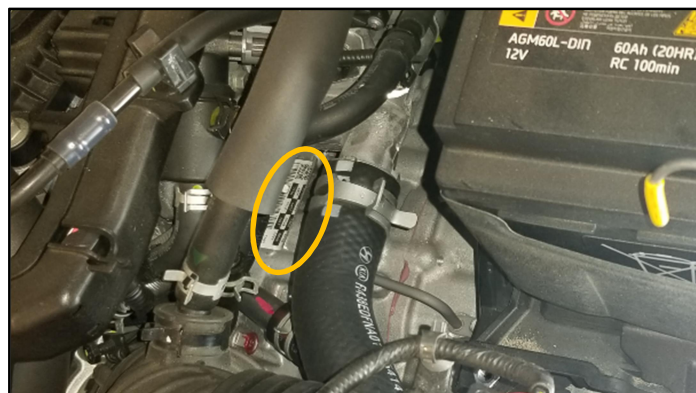
IVT oil pressure characteristics label is located on the IVT bell housing.

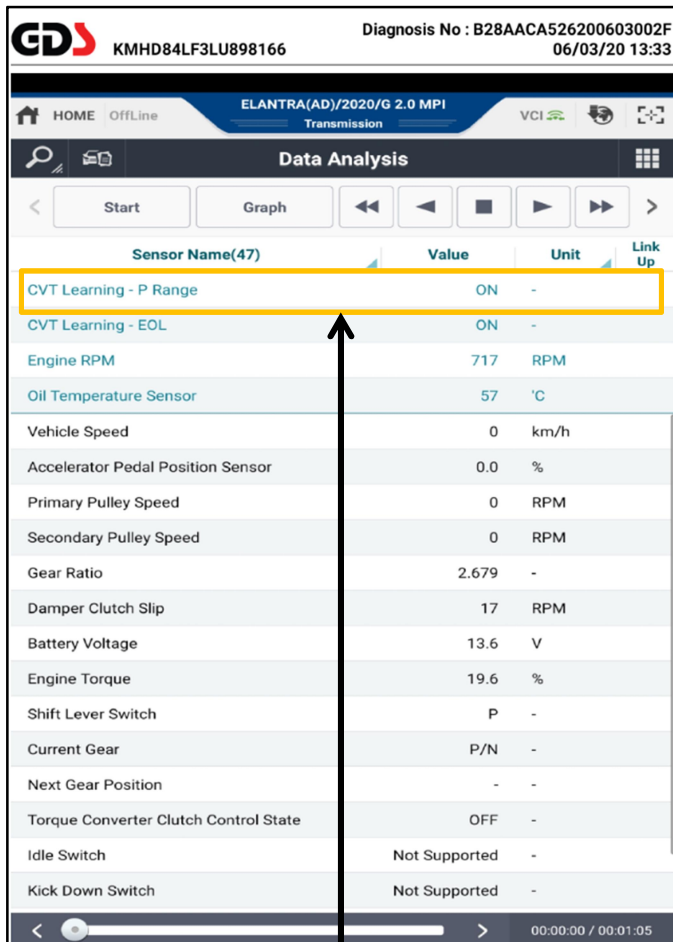
Use the GDS-M to verify the IVT P-Range learning is complete, and check TCU for DTC P1603 (EOL P-Range Pressure Learning Failed).

Learning completion can be confirmed by using GDS-M to verify the IVT ("CVT") P-Range learning value is "ON". ("OFF" learning has not been completed)

- (1) If IVT- P Range learning is not complete, and P1603 is present, Replace the IVT (Refer to **Section D.**)
- (2) If IVT-P Range is not complete, and P1603 is not present, the learning condition has not been met. Re-perform **Section C** - IVT, TCU Learning.
