## Latest Vehicle Concern Fixes

#### EGR Exhaust Flap Sticking- Check Engine Light

16-19MY Range Rover & RR Sport equipped with 3.0L TDV6 engine

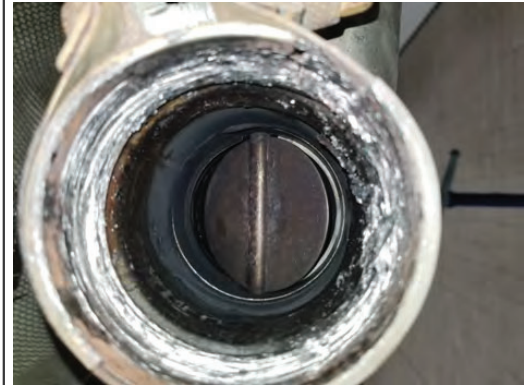
- Check Engine Light illuminated on the cluster
- Customer may have a hesitation concern but this is not in every case

- P0299 or P0234 maybe stored in the PCM in conjunction with exhaust/ EGR related codes

- This issue is caused by corrosion found on the exhaust flap which causes binding/ sticking
- This has been resolved in production.
- Report any cases after the assure VINs
  - SALGA2BK8KA532043 (Range Rover)
  - SALWA2BK0KA421224 (RR Sport)
- Please report any cases that do not have ANY EGR/ Exhaust related codes and only have Turbocharger Underboost/ Overboost codes and result in the replacement of the exhaust flap.
