SERVICE BULLETIN

Classification: EC16-034c	Reference: NTB17-082c	Date: June 29, 2020
------------------------------	--------------------------	------------------------

DTC P0456 CAUSED BY EVAP LEAK AT VENT CONTROL VALVE O-RING

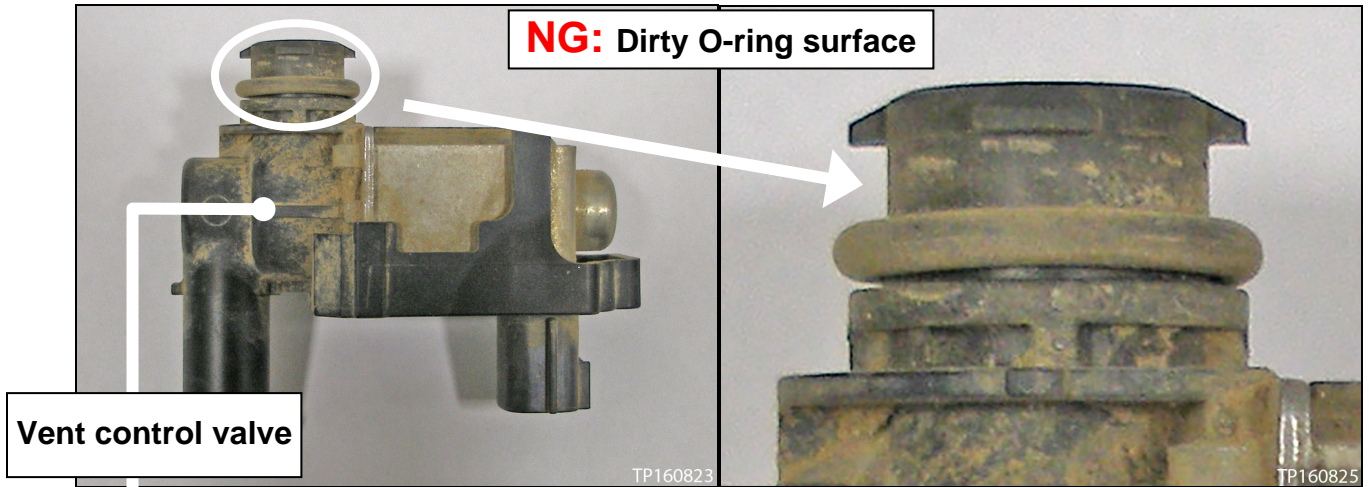
Figure 1

Where vent control valve mounts in canister

This surface must be clean all around

Canister

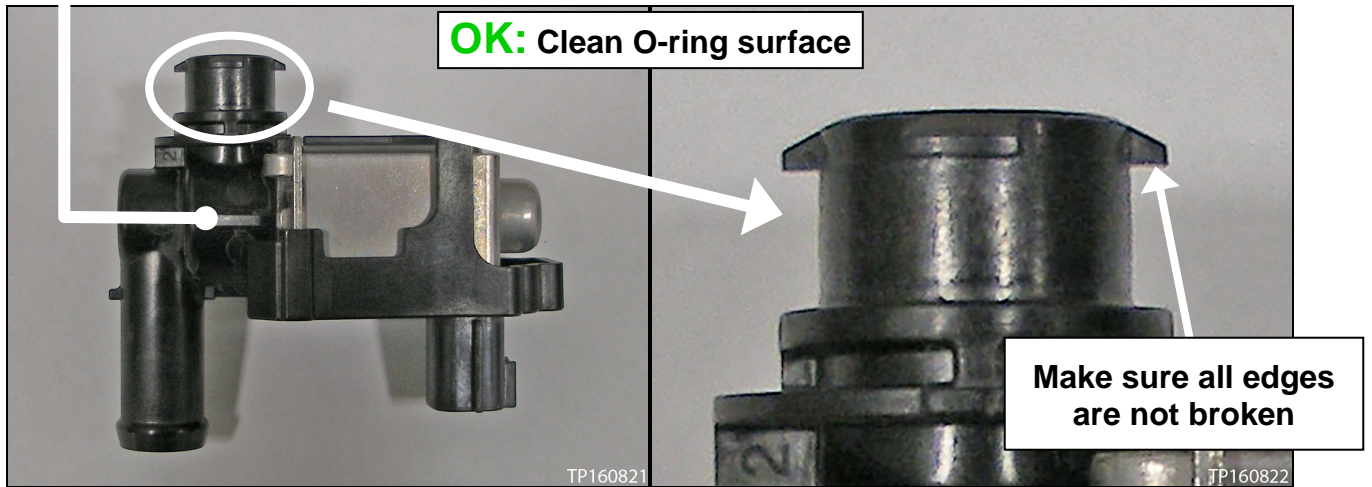
Figure 3

Make sure all edges are not broken

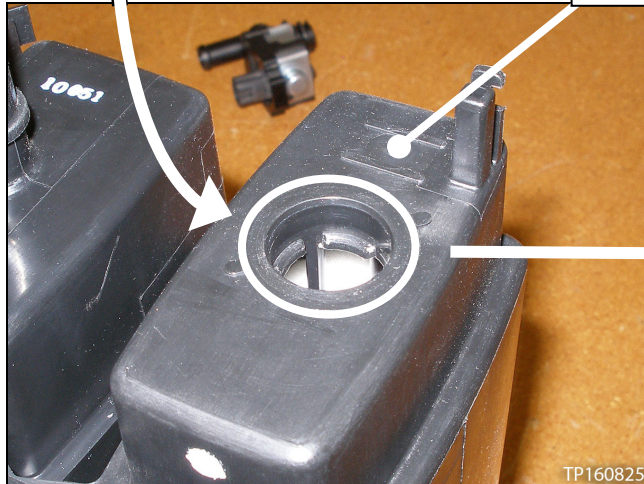
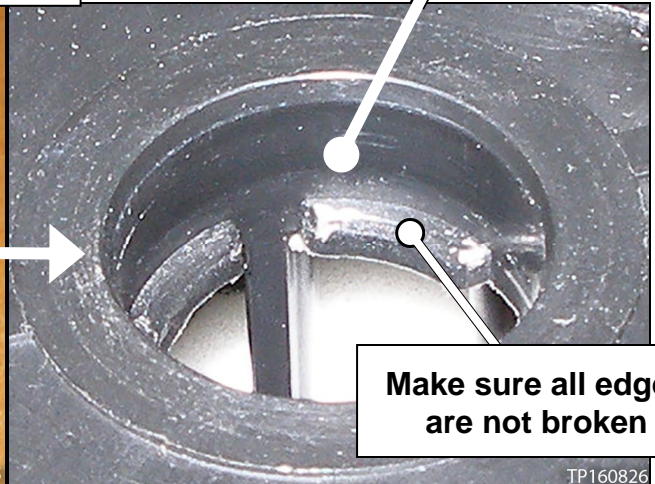
Figure 5

When fully seated (no gaps), O-ring is not twisted or rolled over

O-ring

No gap all around
