SERVICE BULLETIN

EL20-018

NTB20-045

SOFTWARE UPDATE FOR INFOTAINMENT ISSUES

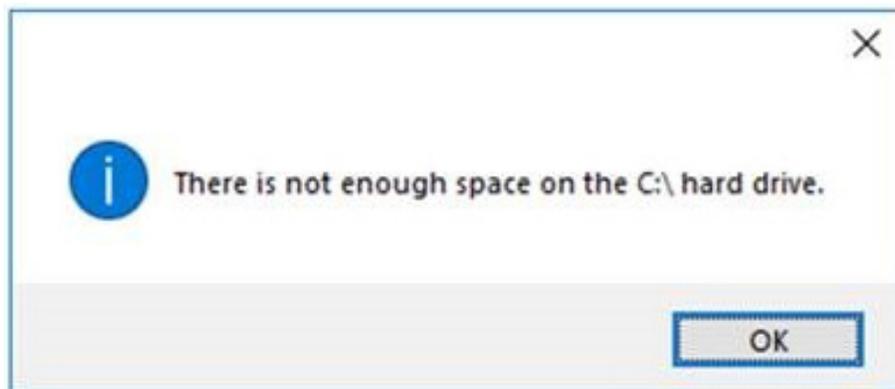
Figure 9

- The update is estimated to take **4 hours** to download to the USB drive.
- If while attempting to download the software to the ASIST Station, you receive the message show in Figure 9:
 - a. First attempt to clear space on the ASIST Station hard drive.
 - b. If space on the hard drive cannot be cleared, email Bosch at **nissan.dealers@us.bosch.com** for additional options.

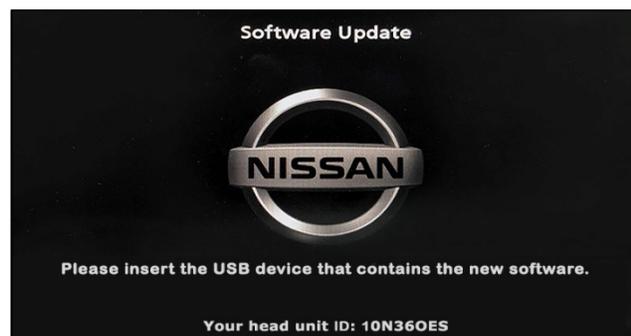
- The screen in Figure 15 may briefly appear. **Do not remove the USB drive.** The audio system will detect the USB drive and continue the update.
