## SERVICE BULLETIN

EL20-020

June 26, 2020

### 2019-2020 ALTIMA; VOLUME KNOB DOES NOT FUNCTION PROPERLY

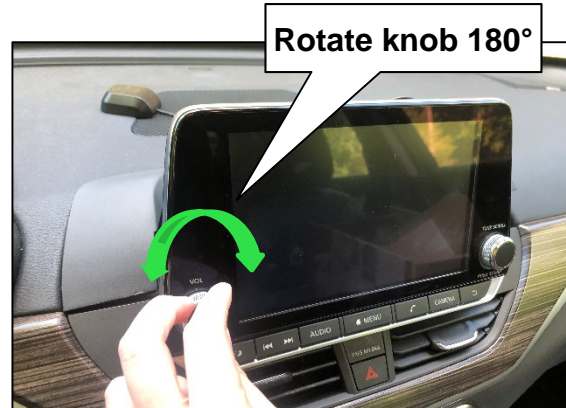
Figure 2

**NOTE:** To ensure a successful repair, step 1 **MUST** be performed to remove contaminate build-up on the full 360° radius of the electrical components internal to the volume knob.

1. Turn the audio and the ignition OFF.
  - a. Rotate the volume knob clockwise and counterclockwise approximately 180° as rapidly as possible for 30 seconds (Figure 2).
  - b. Rotate the volume knob 180° from its current position to remove the contaminate from the opposite side of the electrical component internal to the volume knob.
  - c. Rotate the volume knob clockwise and counterclockwise as rapidly as possible for another 30 seconds.
