Technical Service Bulletin

20 Noises from the fuel line

20 20 27 2059997/1 July 7, 2020.

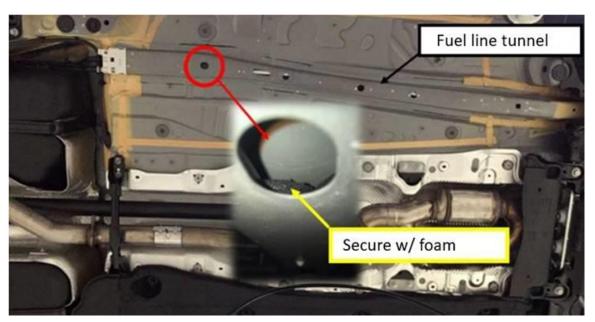
The fuel lines in the longitudinal member start to vibrate in certain operating situations and this creates the noise.

Due to pressure pulsation from the high-pressure pump on engine side the underfloor line in the underbody tunnel vibrates. This vibration causes noise that can also be heard in the vehicle interior.

Figure 1. Location of fuel line of vibration.

- 1. Remove the underbody cover.
- 2. Fill the fuel line tunnel or the space around the line with closed-pore foam (foam that doesn't soak up water) part number 321 201 299. This means the fuel line does not have to be removed.

4. Reinstall the underbody cover.
