Technical Service Bulletin

90 Front camera for driver assist systems R242 fails to calibrate

90 20 56 2059971/1 July 2, 2020.

Model(s)	Year	VIN Range	Vehicle-Specific Equipment
A6, A7, S6, S7, RS6, and RS7	2019 - 2020	All	Multifunction camera

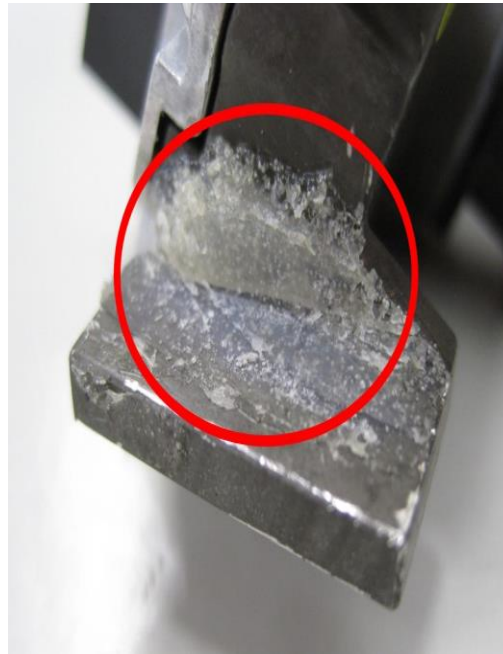
Figure 1. Cleaning of the camera.

1. Remove any adhesive residues from the front camera, as adhesive may have been used for securing it in the holder.

Tip: Protect the front camera against damage when removing the adhesive residues.

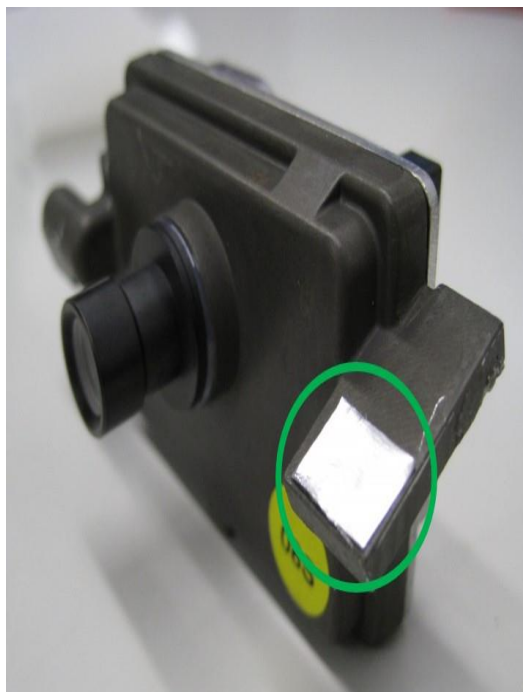
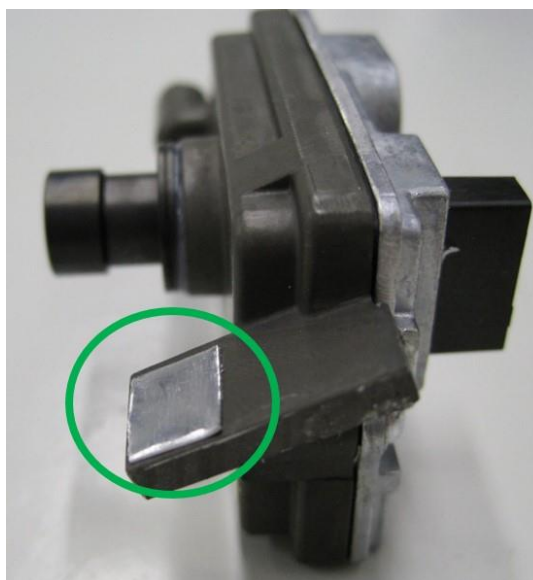
There is a deviation in the mounting of the front camera for driver assist systems R242.

Figure 2. Placement of decal.

Figure 3. Placement of decal.

2. An aluminum foil (part number 4K0 907 231 MTR) has to be attached to the windshield to correct the pitch angle of the front camera. Manufacture a 5mmx10mm decal and stick it on the mounting bar of the front camera previously cleaned with Isopropanol (Figure 2 and 3).
