Technical Service Bulletin

91 Bluetooth call distorted audio or black screen for Apple CarPlay after using backup camera

91 20 82 2046294/4 July 10, 2020. Supersedes Technical Service Bulletin Group 91 number 17-16 dated March 17, 2017 for reasons listed below.

Model(s)	Year	VIN Range	Vehicle-Specific Equipment
A4	2017	All	MMI Radio Plus

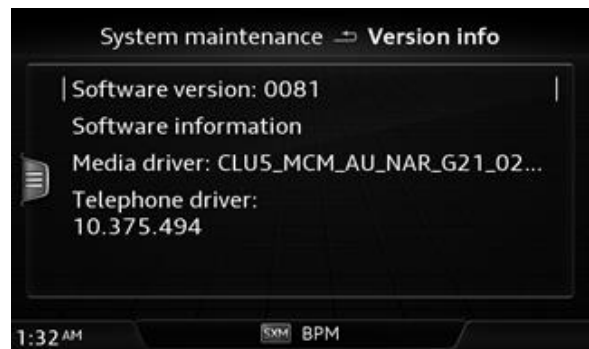
Figure 2. MMI Version Information

1. Verify the customer's MMI requires the software update by going to the *Main Menu >> Settings >> Left drawer option >> Version Information* (Figure 2).

Software versions 0061 & 0081 are only the versions that can be updated. If the MMI is at level 0110, 0116, or 0118, then this TSB does not apply. Cars built after CW22/16 have SW0110 and these vehicles are NOT compatible with this software. Updating a car with SW0110 can damage the MMI.
