# Technical Service Bulletin

| Technical Service Bulletin: TSB180032 | Released Date: 01-Jun-2020 |
| Navistar® Air Compressor Hose Rupture: Fault Codes 3389, 3361, 4729, and 125 | |

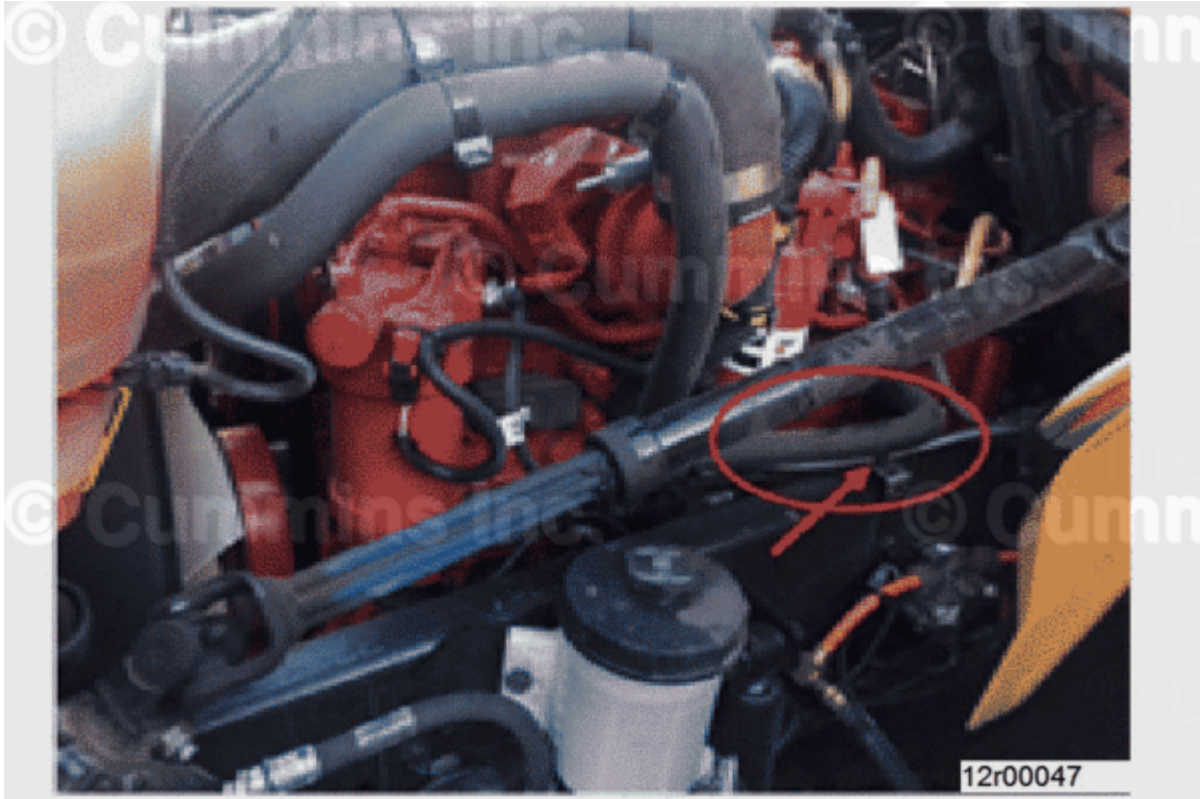
Figure 1, Air Compressor Hose Location.

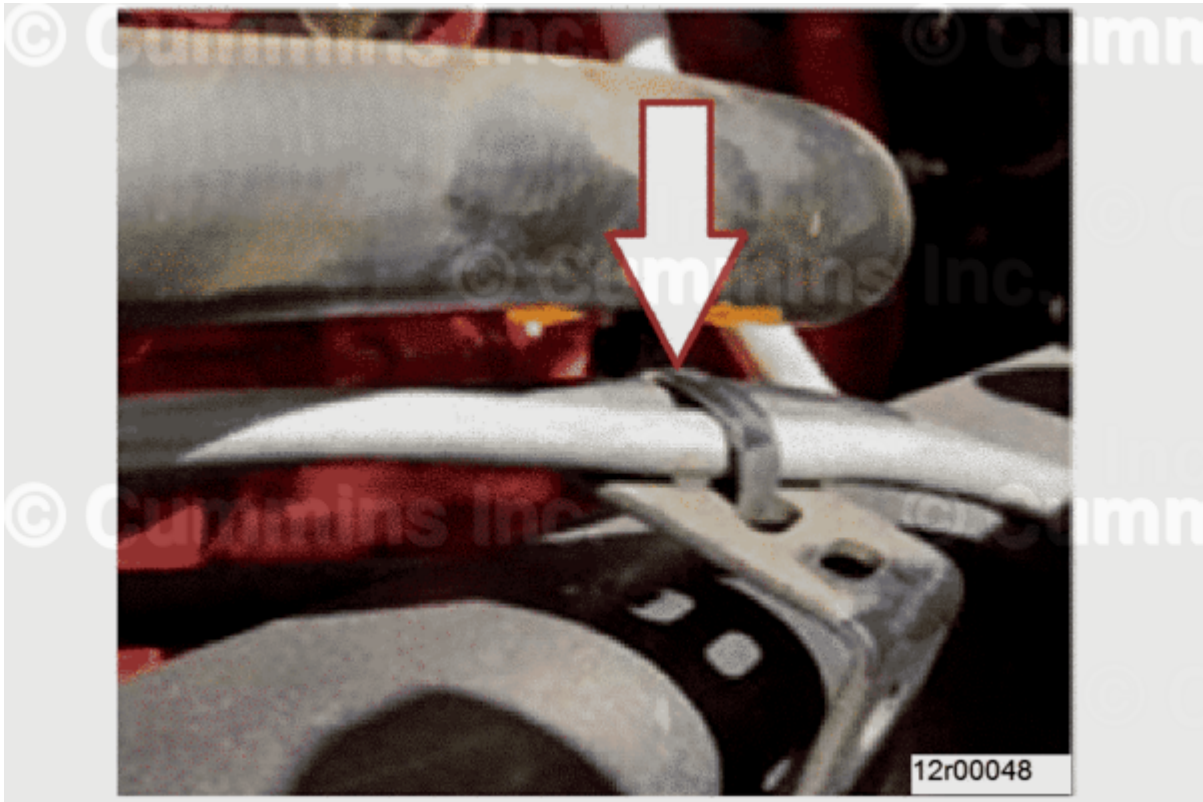
- Zip tie retaining air governor lines is rupturing inlet hose of air compressor. [REDACTED] Part Number 6132813c1 or 6132813c2)

Figure 2, Ziptie Location.
