GLOBAL SAFETY FIELD INVESTIGATIONS
DCS5413
URGENT - DISTRIBUTE IMMEDIATELY

Subject: N192289390 - Special Coverage
Seat Belt Anchor Pretensioner Cable

Models: 2014-2017 Chevrolet Silverado
2014-2017 GMC Sierra

N192289390 Seat Belt Anchor Pretensioner Cable

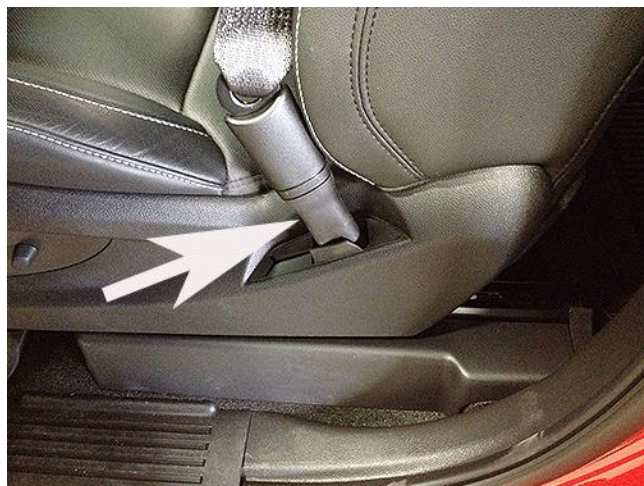
4522278

1. Move the driver seat to the full forward and full down position.

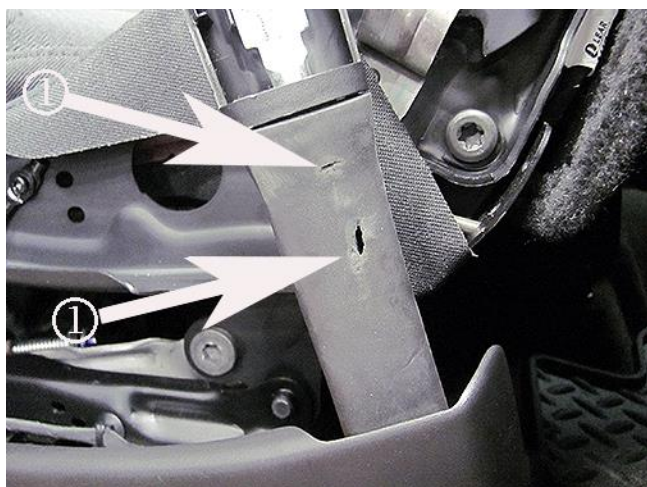
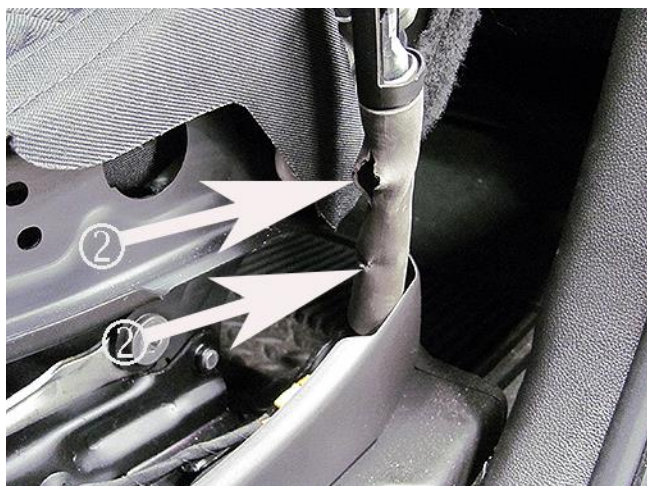
2. Inspect the seat belt tensioner cable cover for damage. Inspect the complete cable cover from the base of the cable to the buckle.

This damage will be in the form of holes (1) or splitting (2).

- If **any damage** is found, replace the driver side front seat belt anchor plate tensioner and the front seat cushion outer finish cover.
- If no damage is found, inform the customer that the special coverage condition is not present on their vehicle at this time.

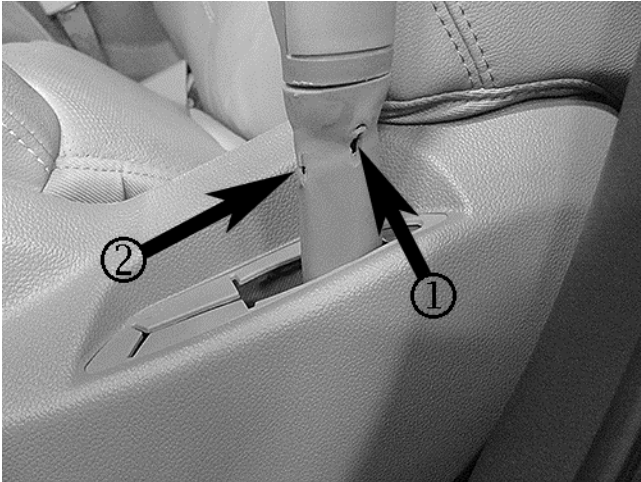
2. Inspect the seat belt tensioner cable cover for damage. Inspect the complete cable cover from the base of the cable to the buckle.

This damage will be in the form of holes (1) or splitting (2).

- If **any damage** is found, take the vehicle to the dealer for service.
- If no damage is found, the special coverage condition is not present on the vehicle at this time.
