Service Update

A202299960 Shift Lever Cable Bolt Not Fully Fastened

Release Date: June 2020

Revision: 01

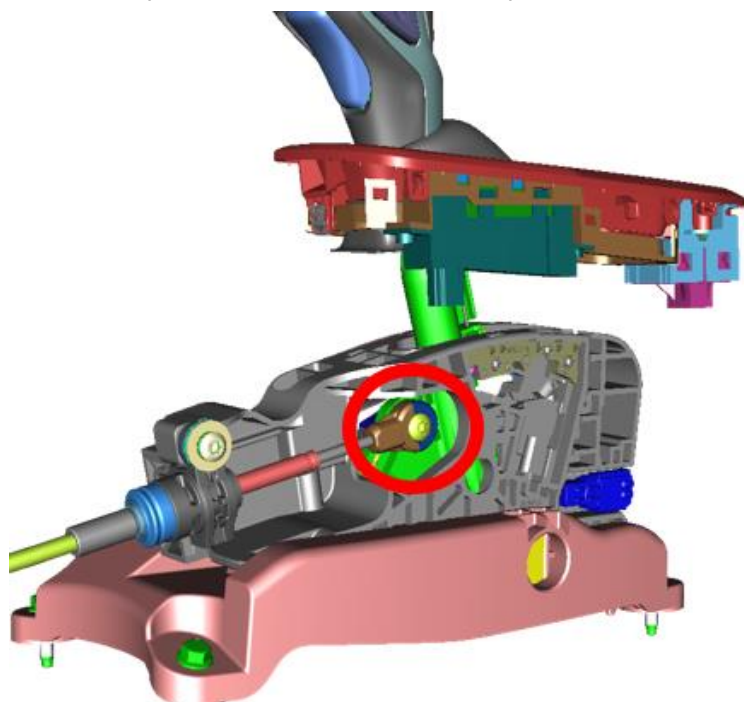
5569860

Condition	The gear shift lever may have a detent feel between Park and Reverse caused by the fastening bolt that is not fully seated and contacting the shifter housing.
Correction	Dealers are to inspect the detent feel of the transmission range selector lever and replace the select cable if necessary.

Caution: During part replacement, check to ensure the circled fastener is fully seated.

4. Replace the Transmission Range Selector Lever Cable. Refer to *Automatic Transmission Range Selector Lever Cable Replacement* in SI.
