Special Coverage Adjustment

N192289160 Rocker Arm Oil Control Valve Inoperative

Release Date: June 2020

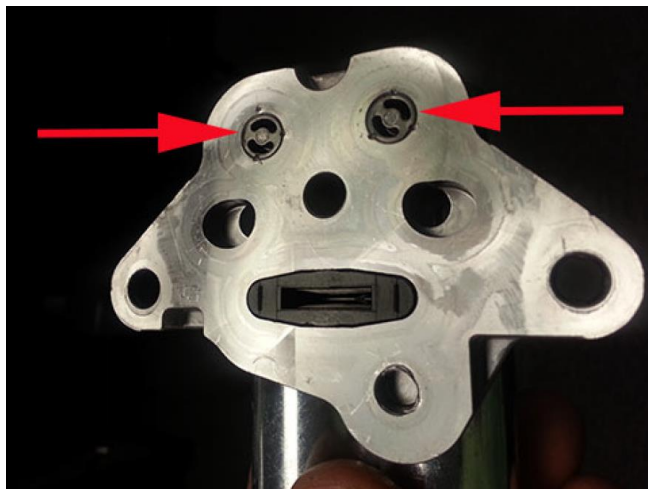
5591365

Components Intact

- If the oil control valve is intact, replace the oil control valve and gasket. Refer to *Valve Rocker Arm Oil Control Valve Replacement (LKW)* in SI.
- If the oil control valve has missing/loose components (1), replace the oil control valve, valve gasket and the camshaft cover. Refer to *Camshaft Cover Replacement* in SI.

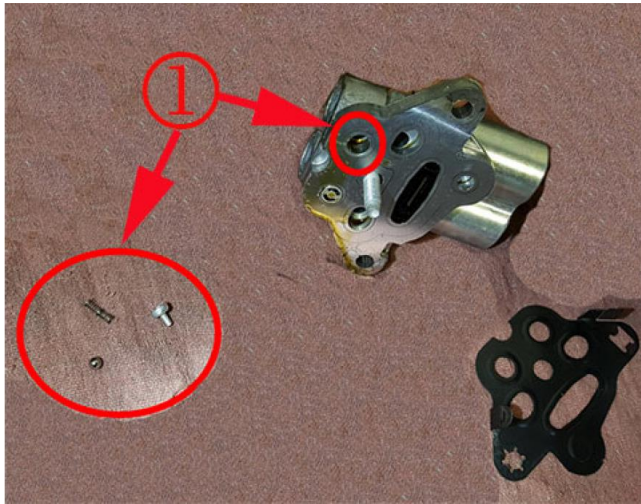
5591366

Missing/Loose Components

NOTE: When replacing the camshaft cover, it is also necessary to replace the two camshaft position actuator solenoids. The O-ring seals are not serviceable and are included with the new solenoids.
