Special Coverage Adjustment

N182188250 Loss of Continuity within Accelerator Pedal Position Sensor Circuit

Release Date: August 2019

Revision: 02

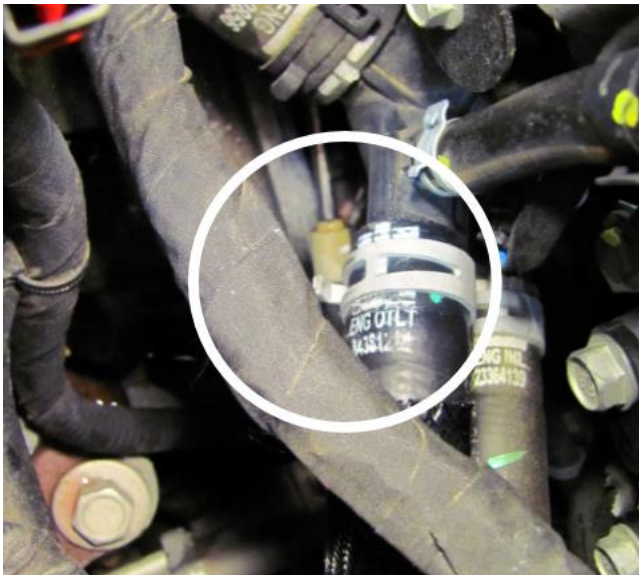
5309871

2. On Malibu (LFV engine) applications **only**, inspect the engine wire harness adjacent to the heater inlet hose for contact with the heater inlet hose clamp on the engine outlet portion of the hose as shown.

3. If contact is observed between the heater hose clamp and the engine wire harness, attempt to rotate the heater hose clamp tabs away from the engine harness, ensuring the clamp stays within the alignment guide markings.

- If the heater inlet hose clamp is **not** glued to the heater inlet hose, rotate the heater inlet hose clamp so the tabs are facing away from the engine wire harness. Ensure the clamp stays within the alignment guide markings. There should be at least $\frac{3}{4}$ inch (19mm) of clearance between the heater hose clamp tabs and the engine wire harness.

- If the heater hose clamp **is** glued to the heater hose, replace the heater inlet hose and both heater hose clamps, being sure to clock the heater inlet hose clamps so the tabs are facing away from any adjacent engine wire harnesses. Ensure the clamp stays within the alignment guide markings. Refer to *Heater Inlet Hose Replacement (LFV)* in SI.

- If any damage is observed to the engine harness, repair the harness and the affected circuits. Refer to *Wire to Wire Repair* in SI. Rewrap the harness in the affected area with PET tape in addition to clocking the hose clamp away from the harness to ensure another rub-through event is no longer possible.
