Technical Service Bulletin

SUBJECT:			No: TSB-20-42A-003
ABNORMAL NOISE WHILE DRIVING WITH FRONT WINDOW SLIGHTLY OPEN			DATE: June 2020
			MODEL: 2018 Eclipse Cross
CIRCULATE TO:	<input type="checkbox"/> GENERAL MANAGER	<input checked="" type="checkbox"/> PARTS MANAGER	<input checked="" type="checkbox"/> TECHNICIAN
<input checked="" type="checkbox"/> SERVICE ADVISOR	<input checked="" type="checkbox"/> SERVICE MANAGER	<input checked="" type="checkbox"/> WARRANTY PROCESSOR	<input type="checkbox"/> SALES MANAGER

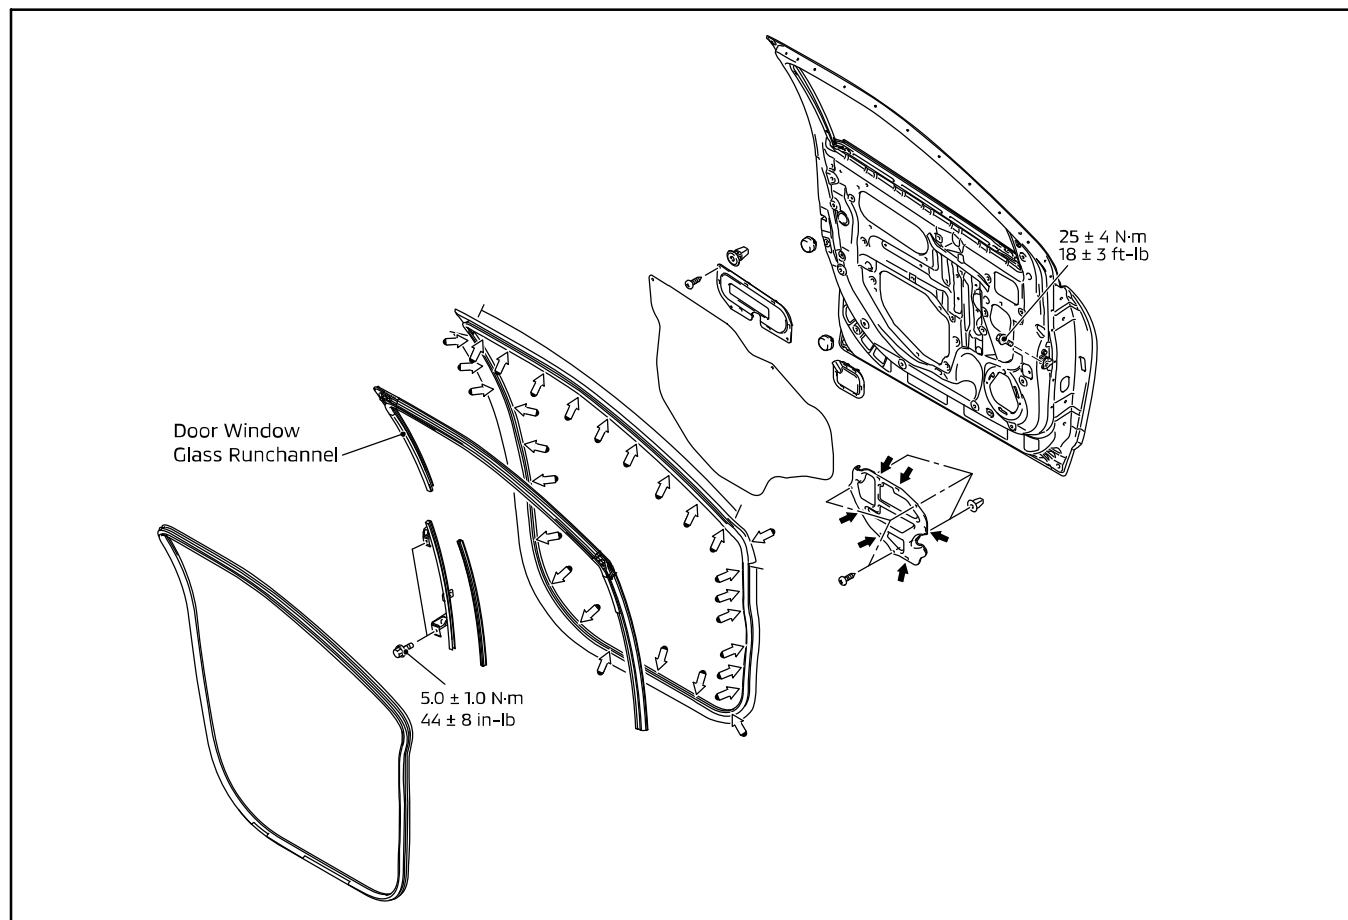
A customer may report a condition where, abnormal noises such as chattering or rattled may be heard while driving with the front window slightly opened. The window shakes while driving, and the glass touches a protrusion on the inner wall of the front door channel causing abnormal noises. The shape of the front door channel has been changed to remove the protruding part which was the source of the noise. This TSB instructs dealers to replace the front door run channel with a new part.

Replace the front door run channel with the countermeasure part.
