TECH TALK

Volume 255 - May 2020

CVT WILL NOT SHIFT OUT OF PARK, DTC P0705, ETACS FUSE #18 (7.5A) BLOWN, SRS LIGHT ON – 2012 & newer Outlander Sport/RVR.

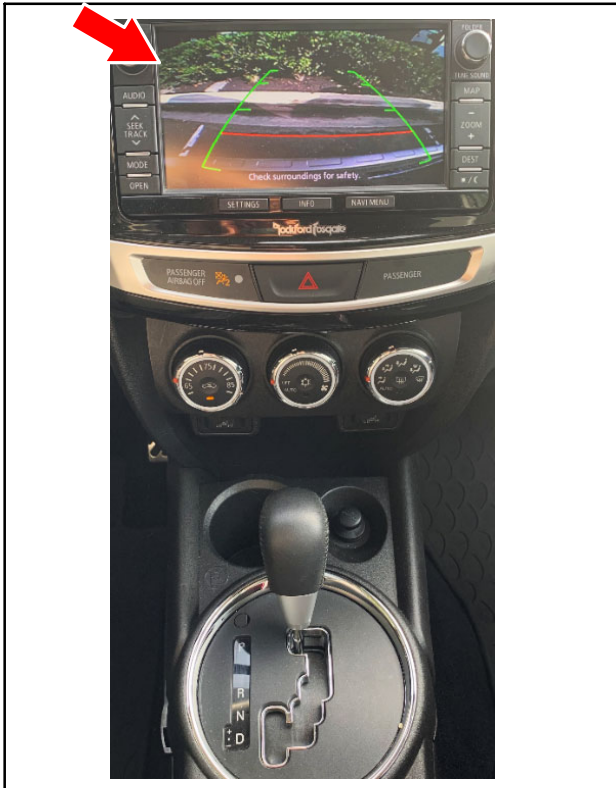
Customers may complain that they cannot shift out of "P" (PARK), transmission warning light is ON, selector lever indication (P, R, N, D) is not displayed on the instrument panel screen, and reverse camera is ON (even though selector lever is in "P"). This condition may be occurring intermittently or may be present all the time. Upon diagnosis, you may find DTC P0705 present in the TCM, and C1747 present in the FCM (for 18MY and newer vehicles with FCM).

Also note, there may be a no start condition if the MID shows "R" (REVERSE).

When working on vehicles showing some of the above symptoms, be sure to inspect the inside mirror connector. Use the electrical circuit diagram in the Service Manual for the automatic anti-dazzling mirror, Group 90, for further details.

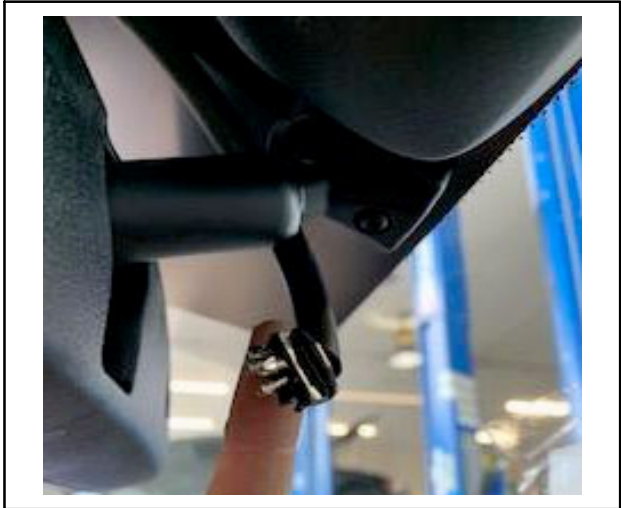
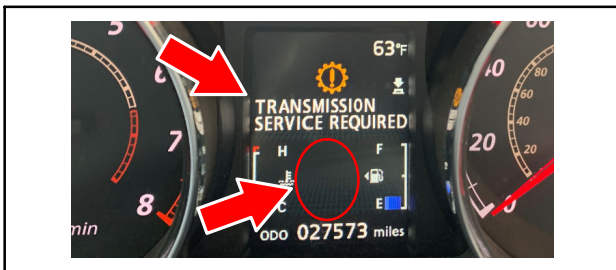
inside rear view mirror due to a short in its electrical connector. The auto-dimming mirror is using the reverse signal from the CVT to disable the dimming in the mirror when the driver is backing up. The short circuit in the connector might occur due to various reasons:

1) Connector damage after windshield or inside mirror replacement.

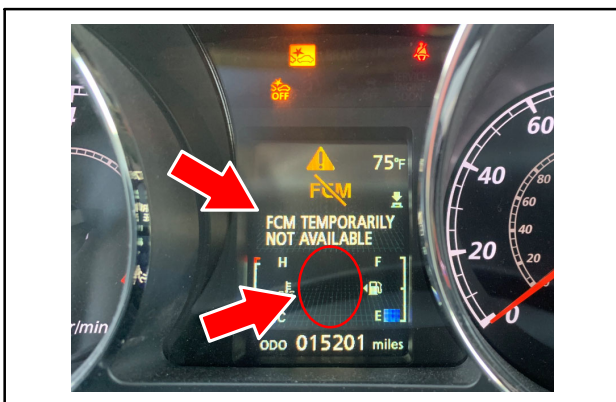
2) Pins are backed out due to objects hanging on the mirror and pulling the wiring harness

3) Metal parts or strands from objects such as necklaces, beads, etc., that are suspended on the mirror, are getting in the connector.

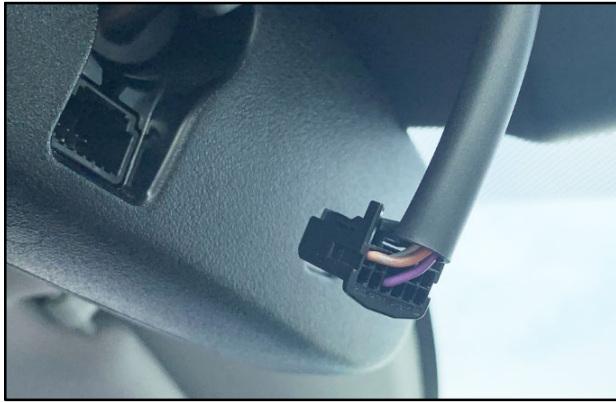
Depending on the trim level the inside mirror connectors will vary. Some vehicles will have a universal garage door opener integrated into the mirror and will have the connector shown below.

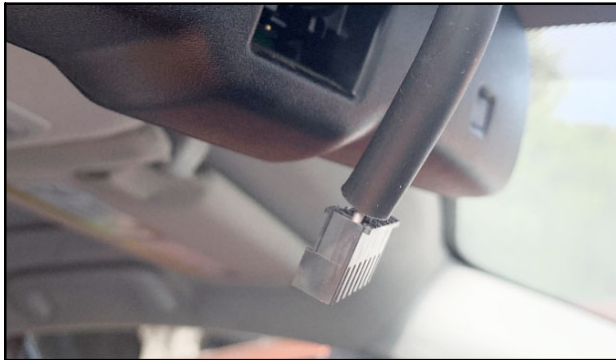
Others will only have the auto-dimming function and will have this connector below.

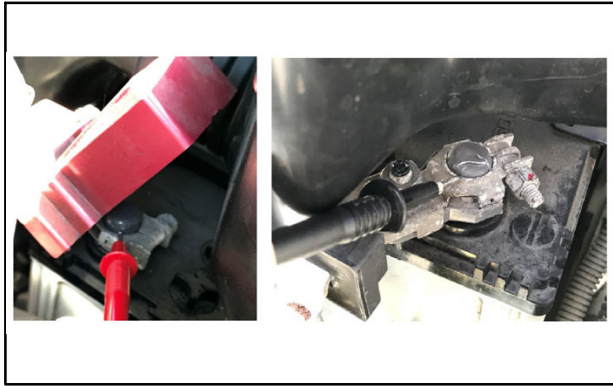
1. Measure and record the voltage at the positive battery terminal and negative battery terminal.
