Technical Service Bulletin

SUBJECT:			No: TSB-20-23-001REV
POTENTIAL TRANSMISSION SHUDDER/SURGE WITH POSSIBLE DTC (CVT-8) - REVISED			DATE: June 2020
			MODEL: See below
CIRCULATE TO:	<input type="checkbox"/> GENERAL MANAGER	<input checked="" type="checkbox"/> PARTS MANAGER	<input checked="" type="checkbox"/> TECHNICIAN
<input checked="" type="checkbox"/> SERVICE ADVISOR	<input checked="" type="checkbox"/> SERVICE MANAGER	<input checked="" type="checkbox"/> WARRANTY PROCESSOR	<input type="checkbox"/> SALES MANAGER

This bulletin supersedes TSB-20-23-001, issued April, 2020, to update the Control Valve part number and make it applicable to all models and model years listed below. Revisions are italicized and indicated by ◀.

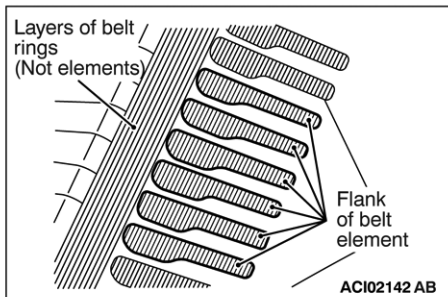
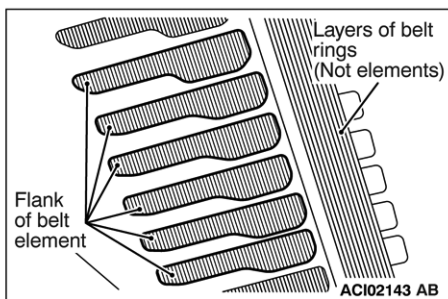
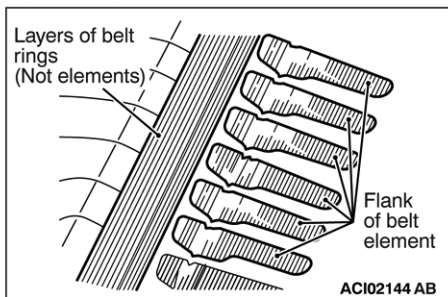
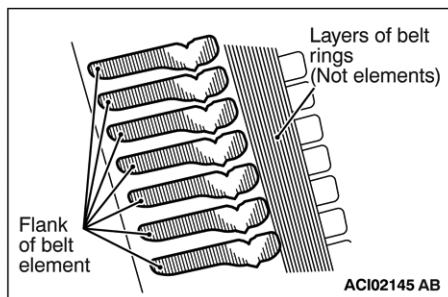
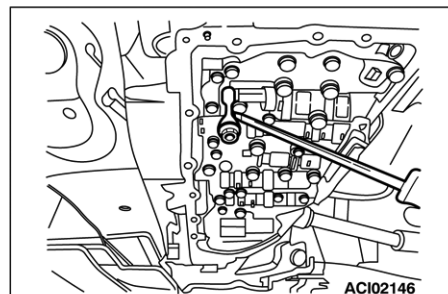
<OK SAMPLES>

- No damage is observed on flanks (grooved surfaces) of belt elements.

< DAMAGE SAMPLES >

- Damages to grooves are observed on flanks of belt elements.

- If damage is found on either side of mating surfaces of the belt, CVT assembly replacement is required.
- If no damage is found on mating surfaces of the belt, a new valve body installation is required. Follow next steps.
