Technical Service Bulletin

PSS 90 Instrument cluster: The center display is black

90 20 60 2057082/2 July 15, 2020. Supersedes Technical Service Bulletin Group 90 number 19-34 dated November 26, 2019 for reasons listed below.

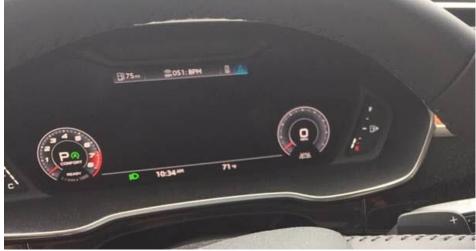
- The central display area in the Audi virtual cockpit is black and does not show the expected tab, no matter which tab is currently selected (Figure 1).
- The tachometer and speedometer remain visible and operational.

Figure 1. Central display area is blank.

• No relevant DTCs are entered in the vehicle.

A software malfunction can cause the center display to blank out.

- 1. Explain to the customer that a solution is forthcoming for the 3rd quarter of 2021 and that no repairs are necessary at this point Do not replace any components for this condition since this will not resolve the customer's concern.
- 2. Create a PSS record in the PSS application through the Pending Service Solutions (PSS) link in AccessAudi (under *Related Links >> Service*), or through the Technical Assistance page in Elsa.
