Technical Service Bulletin

91 MIB2 High: Bang & Olufsen subwoofer settings missing from MMI tone settings menu

91 20 83 2053533/4 July 13, 2020. Supersedes Technical Service Bulletin Group 91 number 20-33 dated February 5, 2020 for reasons listed below.

Model(s)	Year	VIN Range	Vehicle-Specific Equipment
A3	2017	All	MIB2 High

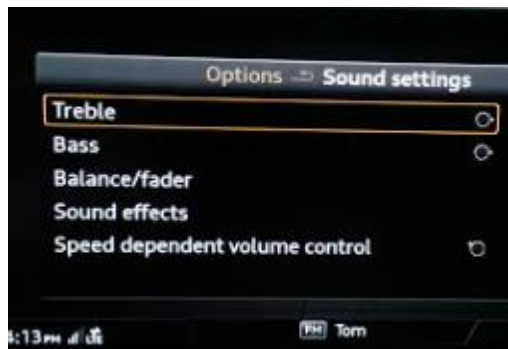
- The subwoofer adjustment is missing in the MMI for vehicles equipped with Bang & Olufsen (PR Code 9VS) and the customer vehicle has MMI Navigation (PR Code I8H & I8L) (Figure 1).

Figure 1. Sound settings are missing the subwoofer option.

The MIB2 software needs to be updated.

Update the MIB2 High infotainment system using either Method 1 or Method 2 according to TSB 2047576: *91 MIB2 High Software Update Instructions (PR Code 7UG)* and use SVM code indicated below:
