# Technical Service Bulletin

## 91 Trunk lid taillight does not work or flickers, DTC B16D5F1, B16D5F2, B16D5F6, and/or B16D7F1, B16D7F2, B16D7F6 stored

91 20 86 2058647/2 July 14, 2020. Supersedes Technical Service Bulletin Group 91 number 20-42 dated March 2, 2020 for reasons listed below.

Model(s)	Year	VIN Range	Vehicle-Specific Equipment
Audi e-tron quattro	2019	000001 – 025632	Not Applicable

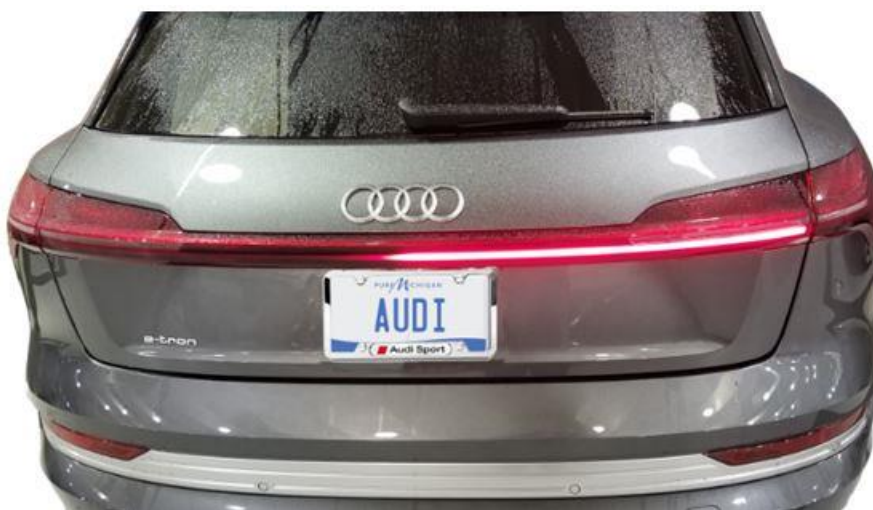
High resistance may form between the printed circuit board and LED contact points within the trunk lid taillight.

This can cause the light to flicker or only be partially lit (Figure 1).

*Figure 1. Partially lit trunk lid taillight.*

1. Attempt to duplicate the customer concern and compare faults to the workshop findings section of this TSB.
2. If the customer concern and/or the faults match, replace the center taillight. Ensure the GFF log is uploaded to GFF paperless.
