STAR ONLINE PUBLICATION

Case Number: S2008000080

Symptom/Vehicle Issue: Intermittent Crank Not Start

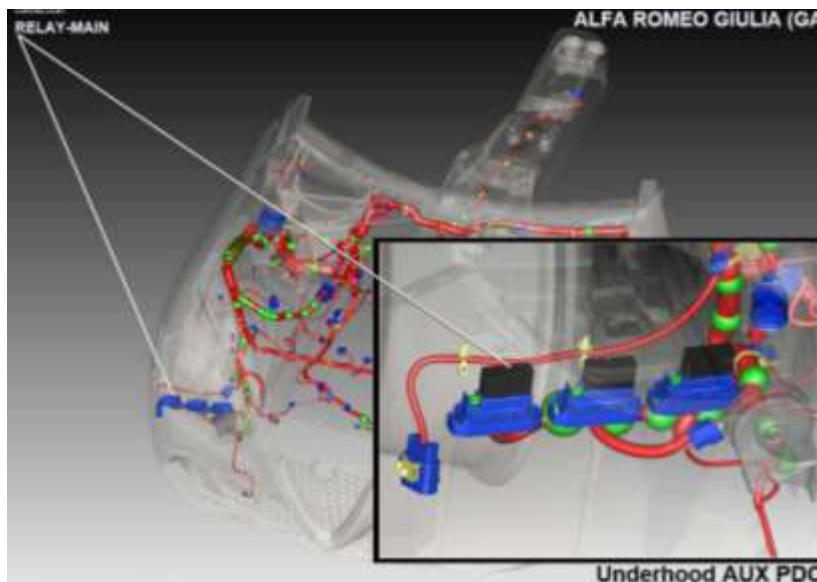
Customer Complaint/ Technician Observation: Owner complains at times that the vehicle will crank and not start. Technician observed the vehicle was setting P0103 - Mass or Volume Air Flow 'A' Circuit High set as stored or active.

Repair procedure: Inspect, test and replace the involved main relay as needed.
